# **CONSERVATION MASTER PLAN** OF THE HISTORIC Center OF SHEKI

The State Tourism Agency of the Republic of Azerbaijan  
**2020**

**Historic Centre of Sheki  
with the Khan's Palace**  
inscribed on the World  
Heritage List in 2019

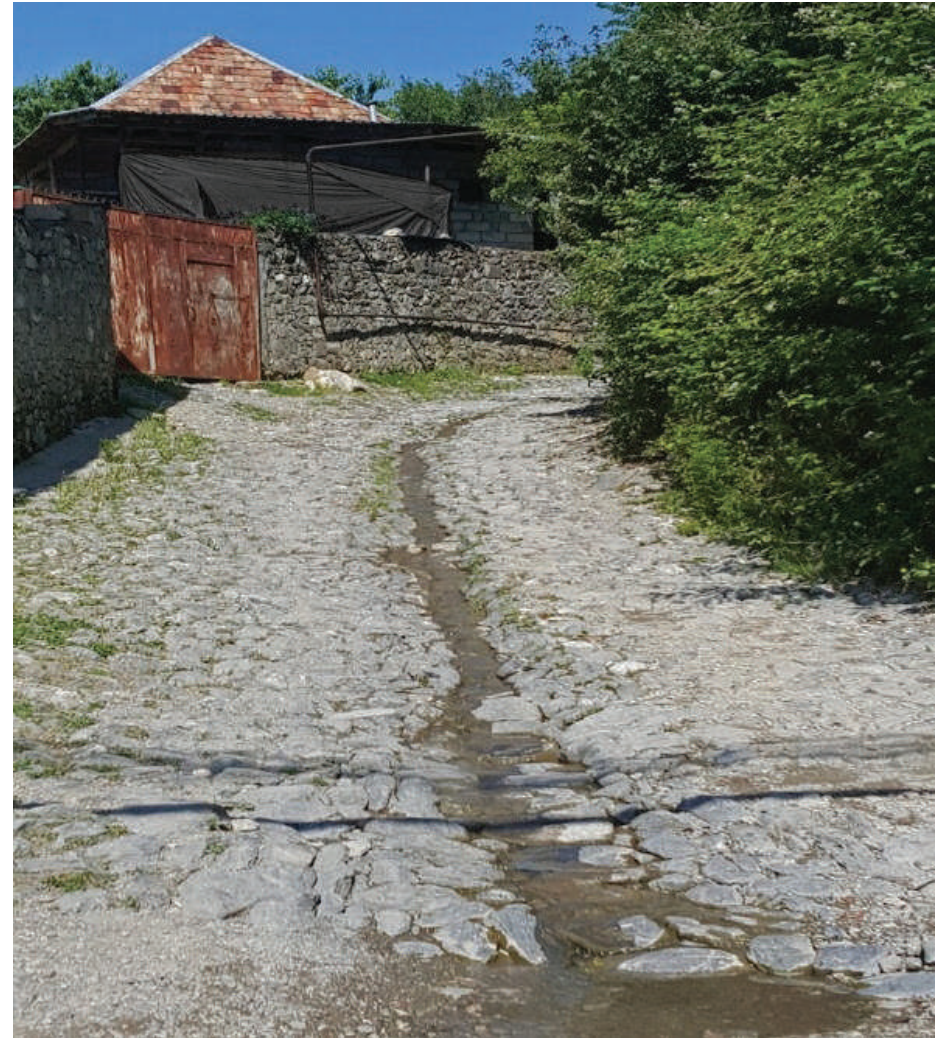
**Figure 3. Old ditch in the village of Kish**

In the traditional preparation of the bottom, the soil is soaked in abundance and then levelled. A level of coarse-grained sand is laid out on the ground, and the installer takes a pebble from the pile, sinks it into the sand by hand or into a small hole made with the hammer's pen and then sticks it into position with two or three strokes data with the widest part of the same tool so that the heads protrude evenly. Once the laying is finished, the mantle is sprinkled with sand and sprinkled with water so as to lubricate the sand and make it penetrate completely between the individual components that, under the action of blows, lower and fit together with a strong contrast lateral. The disposal of the water is entrusted above all to the draining properties of the pavement and to facilitate the drainage of the water the pebbles are placed with the major side in the same direction of the slope of the road. The entire mantle is shaped to direct the flow towards the "impluvium" known as ditch by means of a concave profile converging from the two parts towards the longitudinal axis.

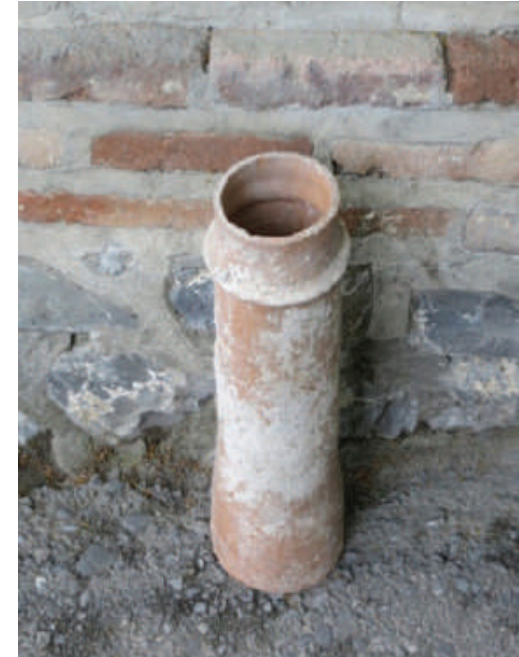
Figure 5. Ancient terracotta pipes

tube), *golgiran-lyulya* (hand flowing-tube) and *tapancha-lyulya* (pistol-tube), which were used for yard branches. Diameter smaller for straight pipelines, in order to increase water speed (Fig. 5); big to slow down where the pipes undergo a curve. The Reserve area used water from the sources of Tajlyg, Haji Hasan. In the most cases water flew along the open bed that led to its contamination by rains and mud.

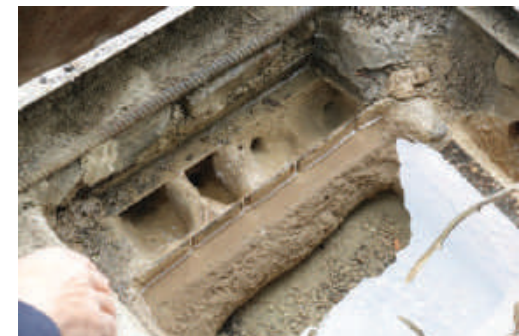
Figure 6. Distribution well with comb distributor

The clay waterlines are interrupted with numerous distributing wells *taksimgez* and completed with water-distribution outlets in the form of a pouring stream. The *taksimgez* is a small quadrangular pool used instead of a water measuring device, which monitors the water flow in water pressure reservoir of the present-day waterlines. Every 20 m on the distribution line there was an inspection well; at the distance of 50 m the tubes branched off supplying water to separate residential areas. Inside the distribution wells there is a comb divider, formerly made of rammed earth, today in metal, to divide the portions of water into the different properties (Fig. 6) The remains of earthenware water pipe are the monument of town planning of Sheki. The water was flowing from the mountain rivers through earthenware pipes which was interrupted by distribution wells and ended in a large number of the water-supply points. In order to show the high quality of these pipes, we note that even with a well- developed modern town water supply, the parts of the earthenware water pipes are used along with modern lines.

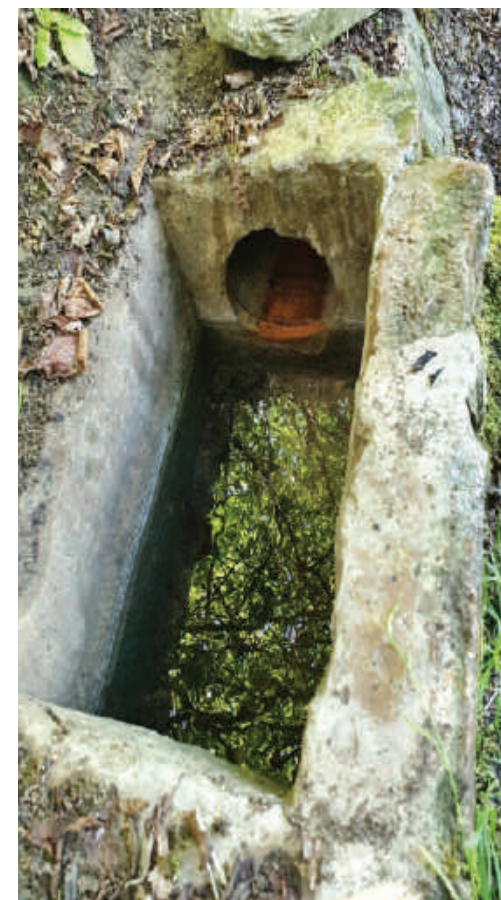
**Figure 7. Tajlyg water collection points near the source**

Today there is a water reservoir in the upper part of the Gurjana River in Agamaliogly Street. It is to be noted now Tajlyg and Haji Hasan networks is only about 50-60% of earthenware pipelines with a diameter of 60-100 mm. The rest of the pipelines is substituted with asbestos and cast iron pipes.

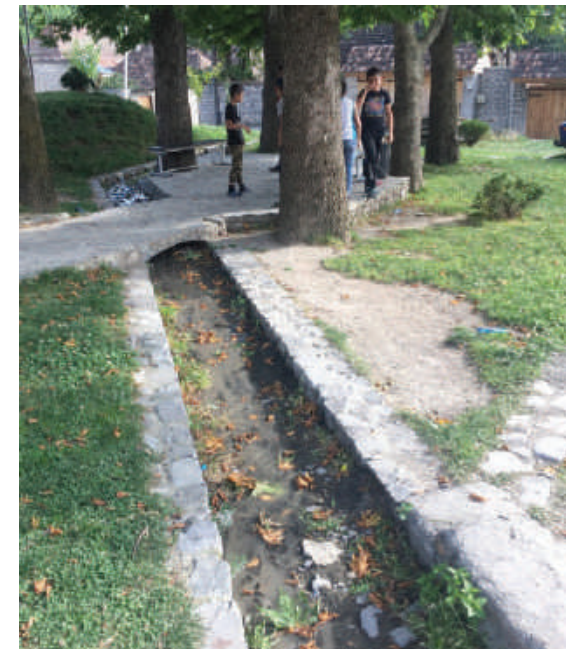
Figure 13. Channelizations and surface sliding systems.

The surface water supply system has been also degraded. In cases where this is maintained, interventions were introduced with the introduction of hazardous materials such as asbestos. These materials, in contact with water and atmospheric agents in general, become more brittle and deteriorate, producing fine powders and fibres that are carcinogenic, polluting the watercourses.

The road system (except for the main one) and the squares have been intervention, thus changed historic views. There is no continuous maintenance, necessary to preserve these types of roads made of stone or earth. The deterioration has undergone further growth due to the increase in urban traffic.

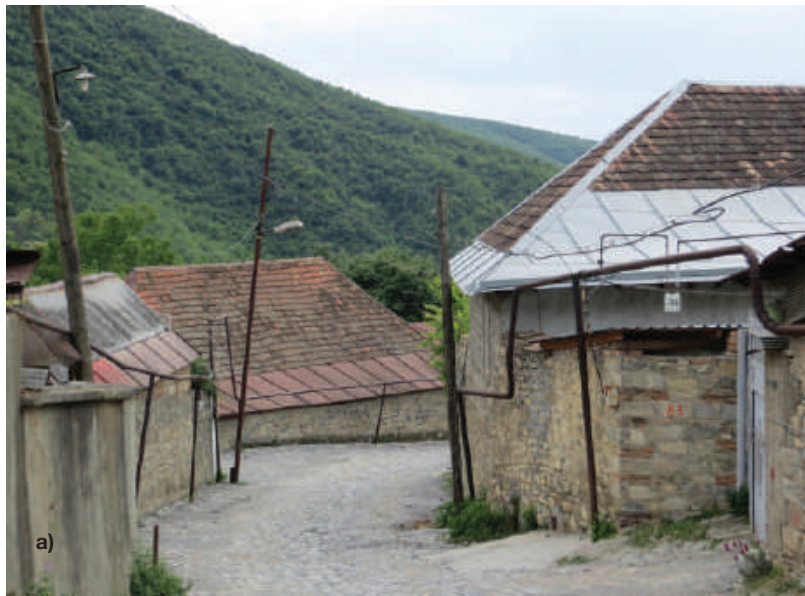
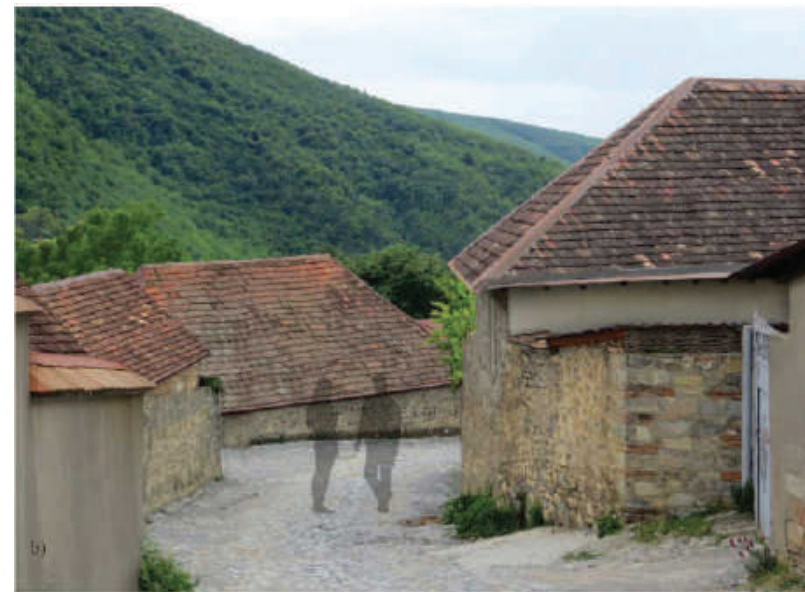
**Figure 16.**

FIGURE 16: The current situation (a) is largely

Permissible height of buildings is adopted in accordance with existing historical buildings to the level of the ridge of a roof (max 1 or 2 floor).

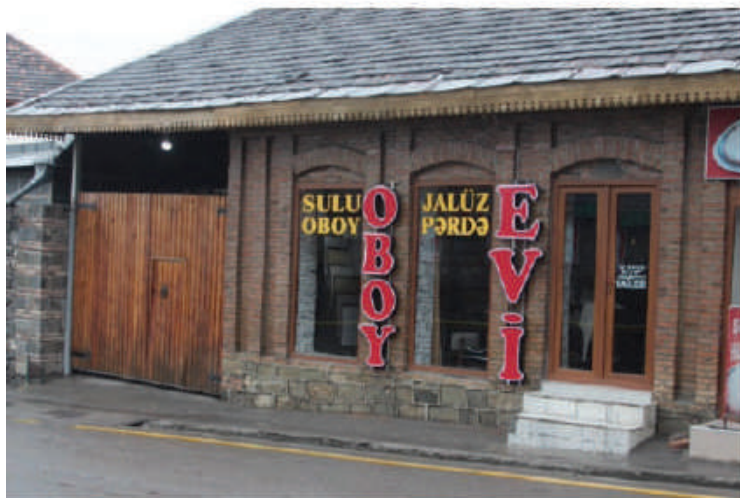
Figure 17. Scale of title is adequately huge in comparison with building with elements of surrounding.

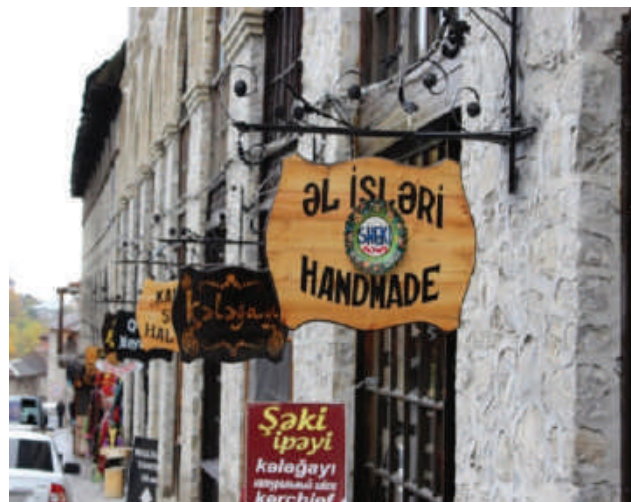
Figure 18. Despite some attempts, the adapted sign boards are not appropriate with the traditional elements and ornaments

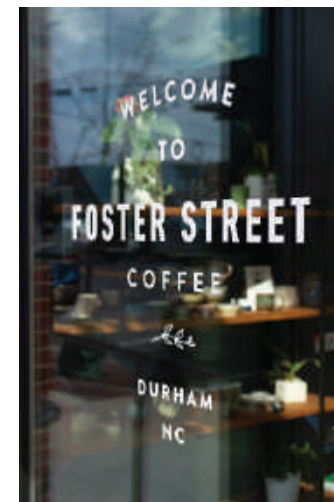
Figure 19.

Titles glued or printed to glass is a common approach in both historical and non-historical areas. (Fig. 19) The approach significantly lessens the visual pollution and creates unison advertising which can be used in the Site as well.

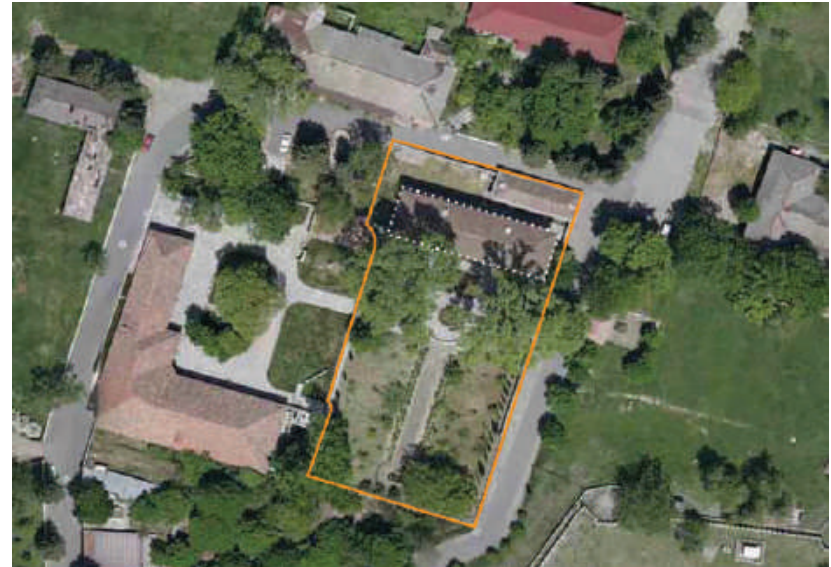
Figure 22. Position plan of the Khan's Palace (2020)

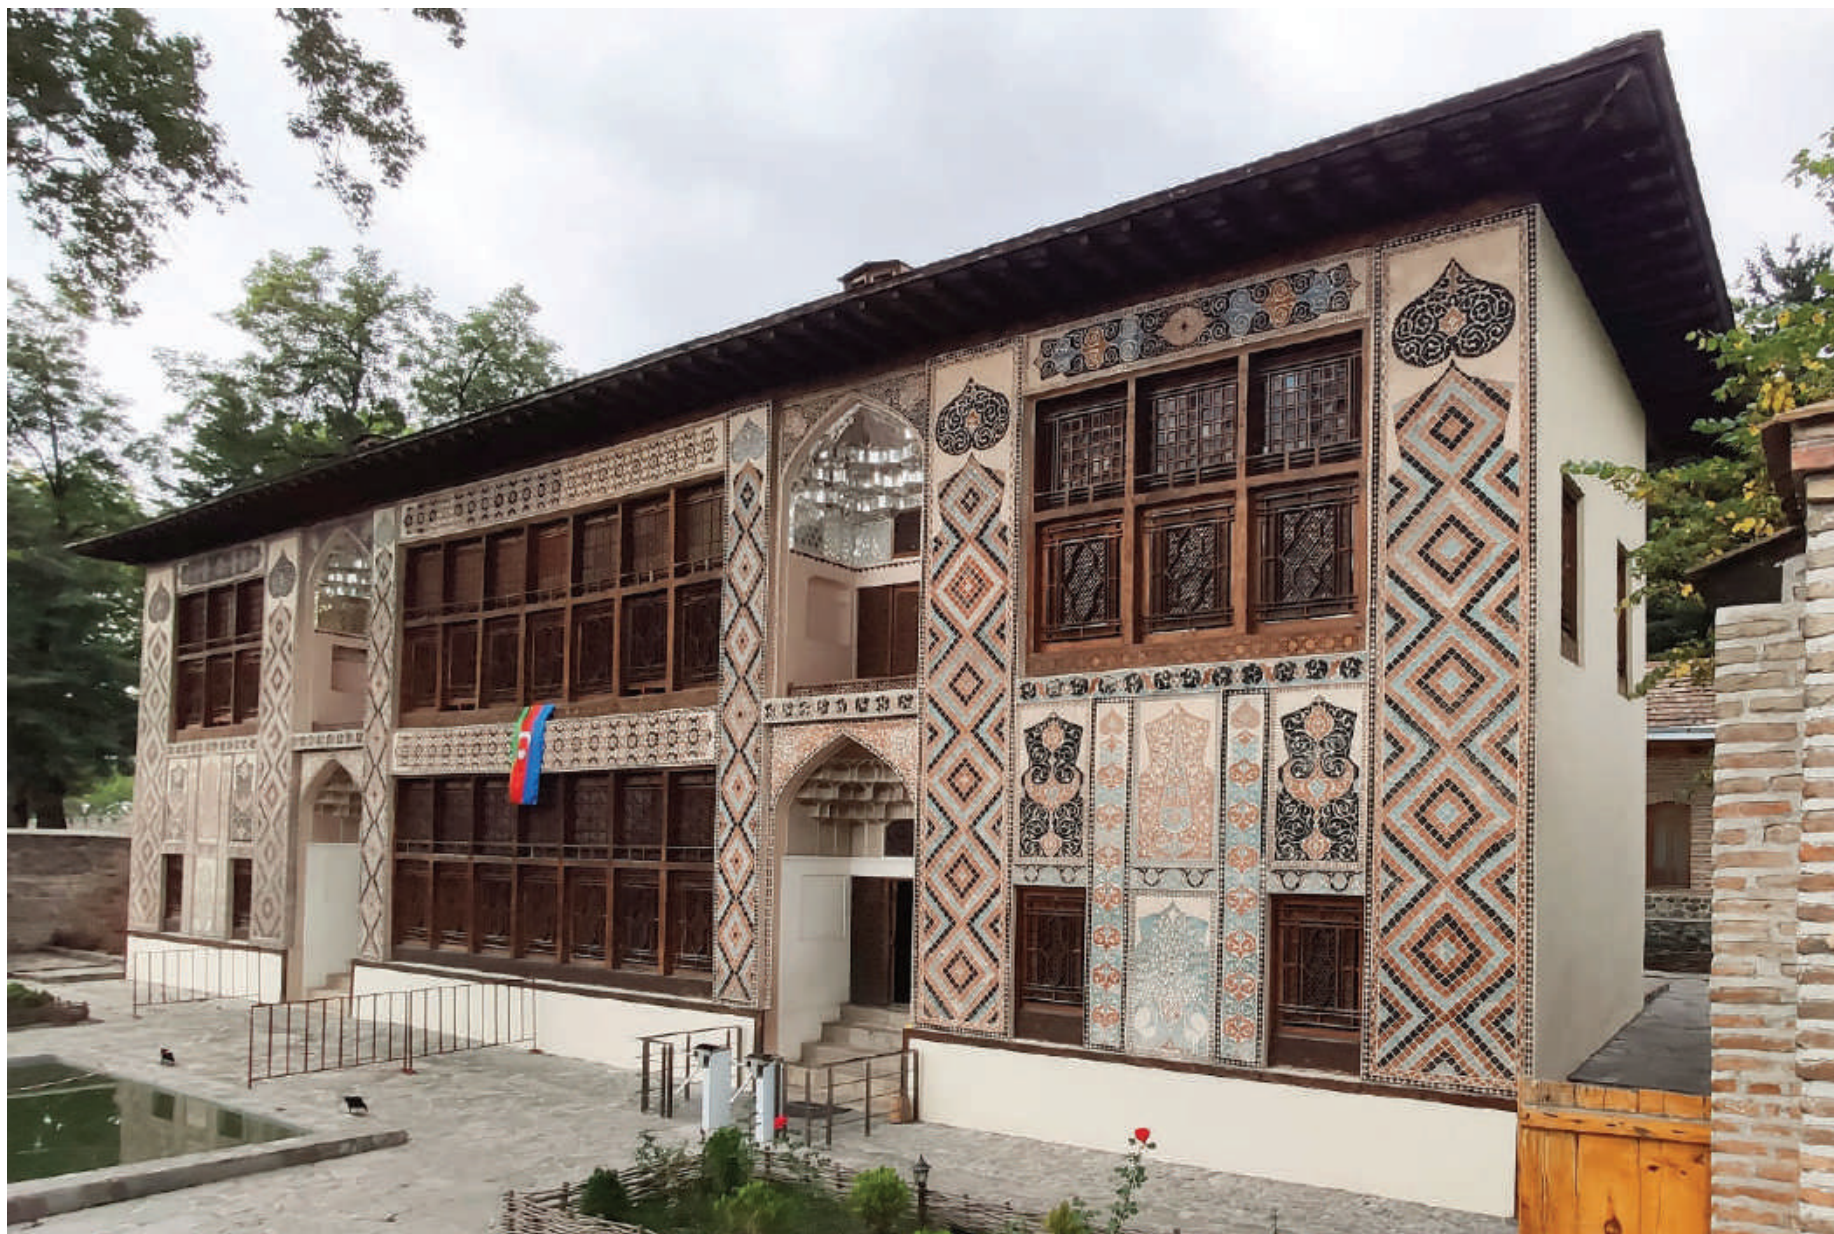
Figure 26. Southern and northern façades of the Khan's Palace

The northern façade consists of a plastered flat surface with a simple solution deepening at the edges. The main decoration is a large fretwork panel opening from the hall on the first floor. The northern façade also features sgraffito patterns following the lines of interior walls. However, these patterns have simpler execution, unlike those on the southern façade, and are made of only two colors – light yellow and dark brown. The western and eastern façades are very simple in execution. Only the doors with stairs are found on the plastered façades. On the west façade, there are also two windows and a door on the first floor opening into a staircase leading to the roof. One can only guess the initial design and layout of this door and staircase when it was completed. According to a historian of architecture, Leonid Bretanitsky, there was possibly a wooden staircase starting the northern façade and ending at the door on the first floor of the western façade. There is no additional information about this possible staircase.

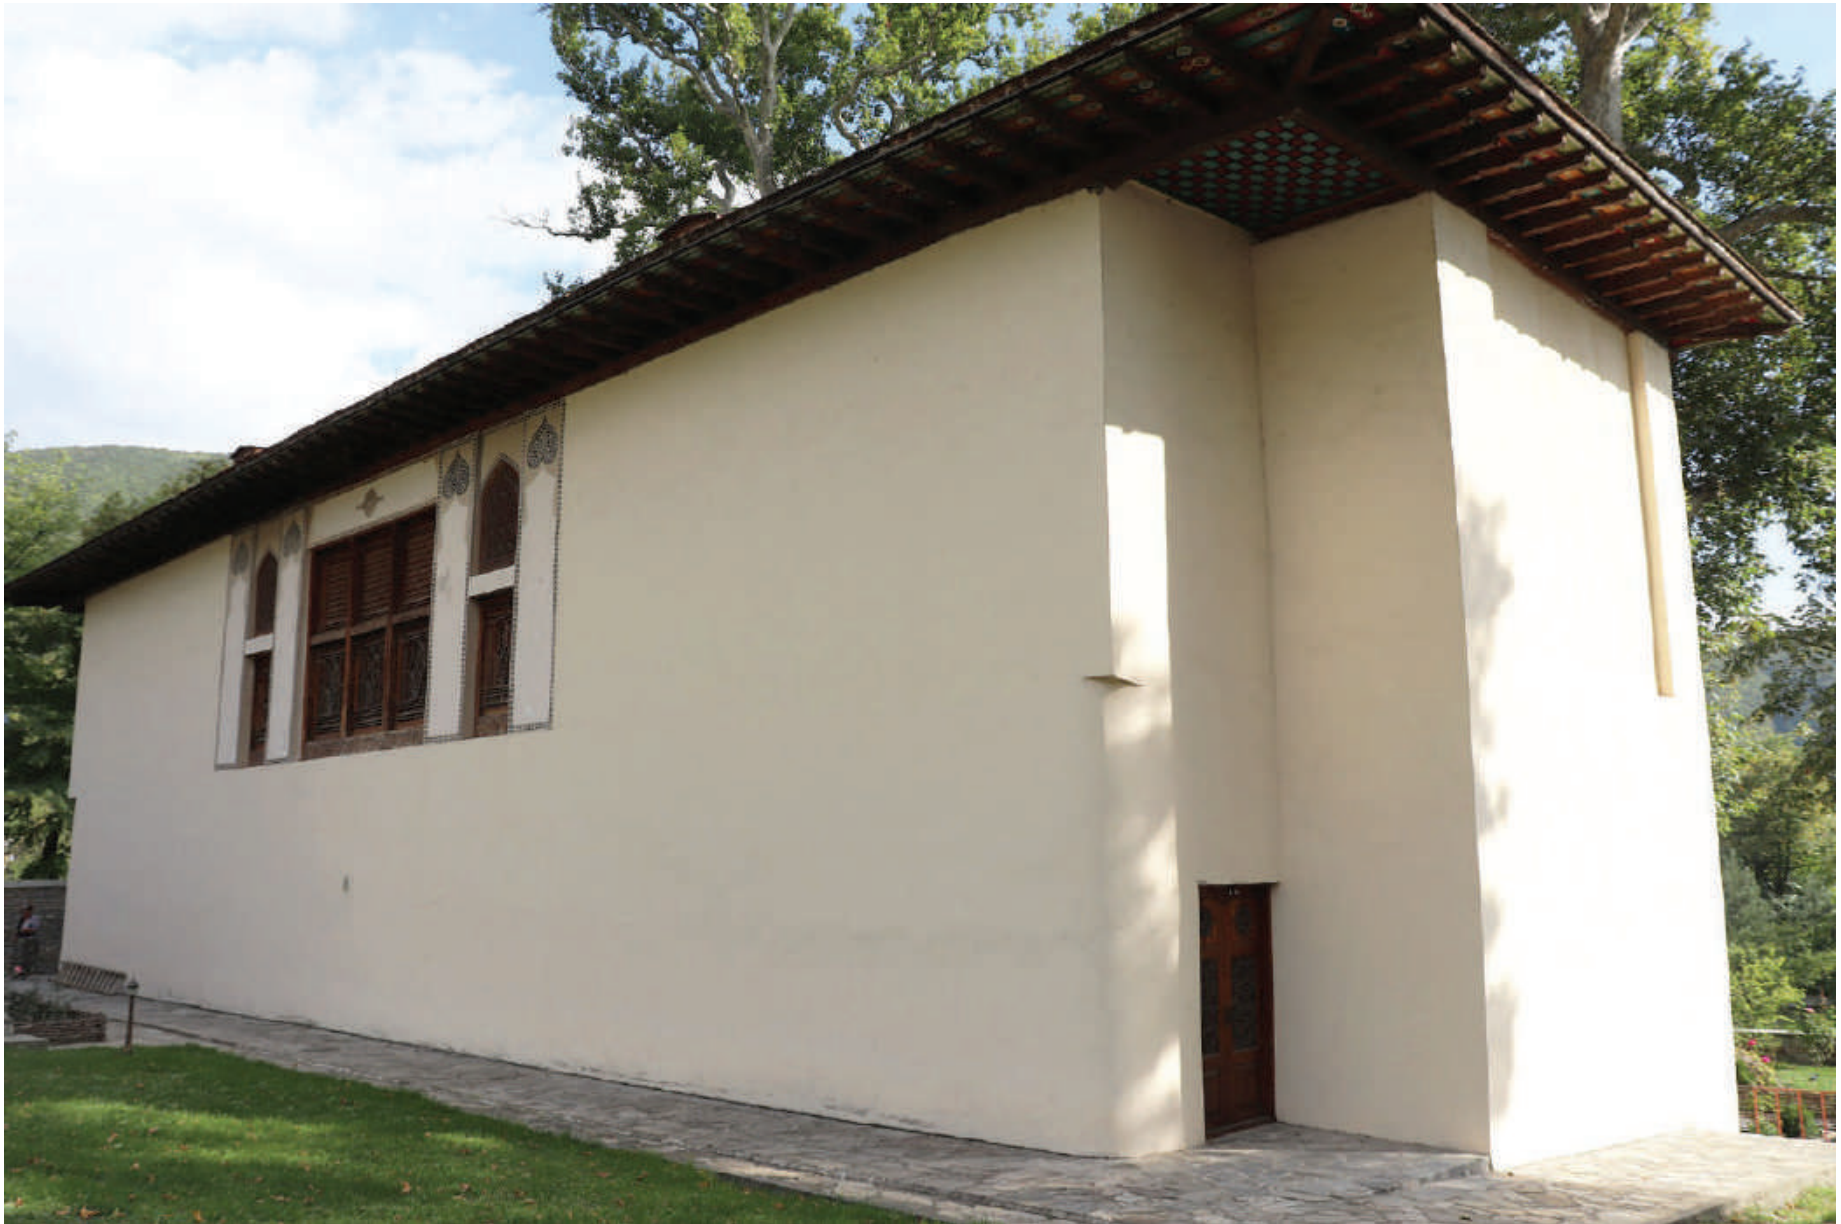
Figure 27 . Southern and northern façades of the Khan's Palace

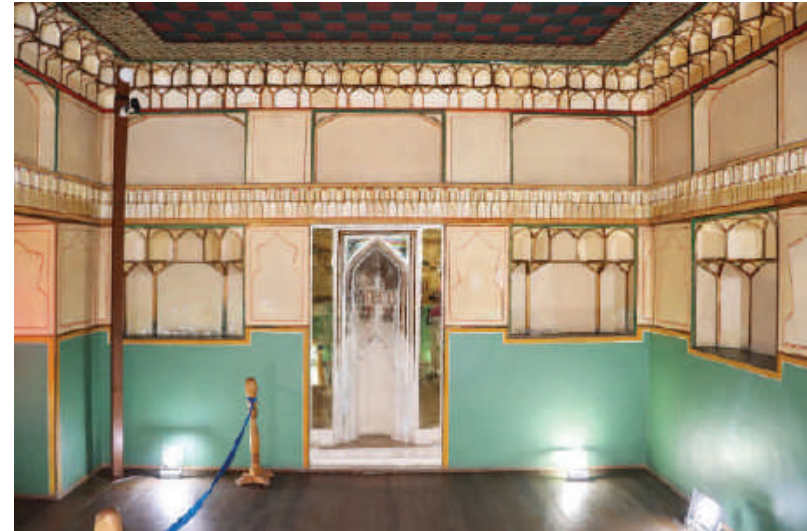
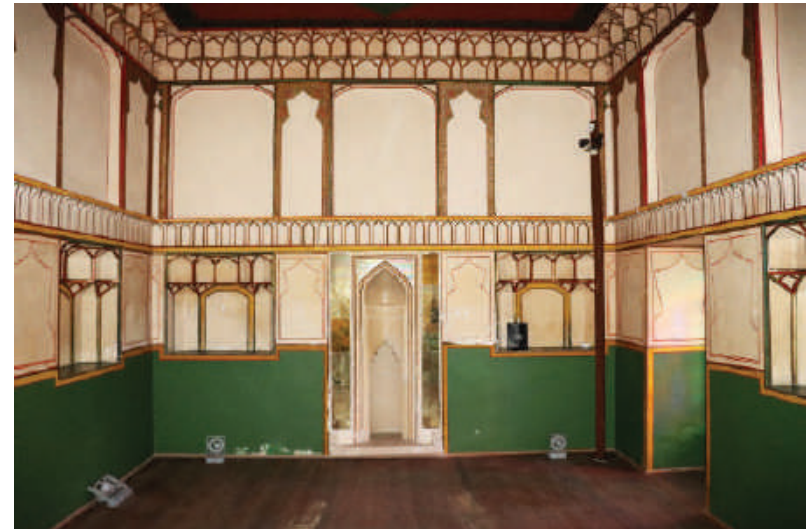
Figure 28. Side rooms on the ground floor

the ground floor is located between the two corridors. Two two-meter interior walls from the northern wall divides the central hall into the main hall, khan's private room (khannishin or shahneshin), and two other small rooms. Thus, the khannishin were reserved for the khan, two small rooms were used as closets, and the main hall was reserved for guests. There are no windows in the two small closet rooms, and light enters only through glassed fretwork windows over the entrances. There is a mantelpiece built into the northern wall of the khan's private room, and it used to have a marble fountain in the middle. The walls of the hall are divided into three tiers. The lower tier is a flat surface up to 1 meter high decorated with carpet-like ornaments with octagonal stars. In the second tier, there are niches completed with stalactites and in the upper tier, these niches are completed with arches. A wide belt is placed between the second and third tiers. The transition from the third tier to the ceiling was executed with stalactites.

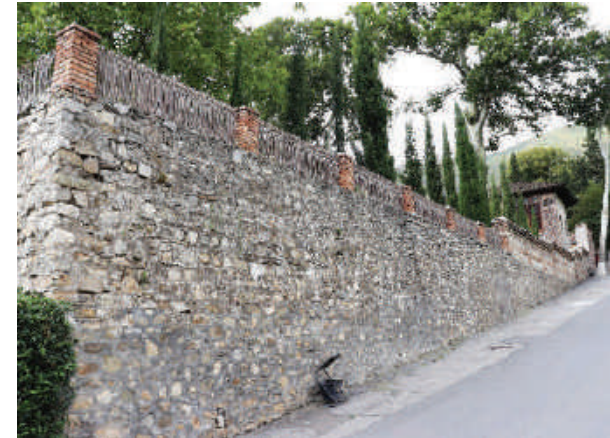
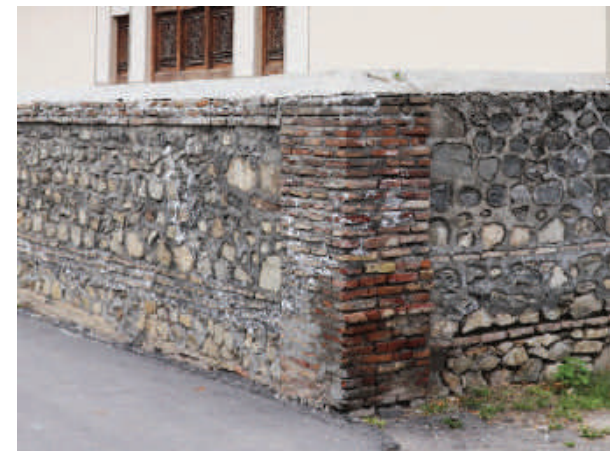
Figure 35. Privacy walls of the Khan's Palace: a. south-eastern corner b. north-western corner

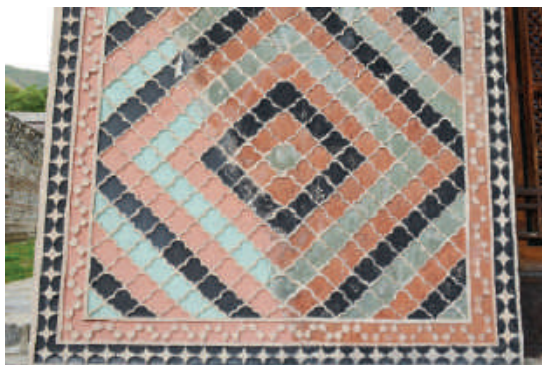
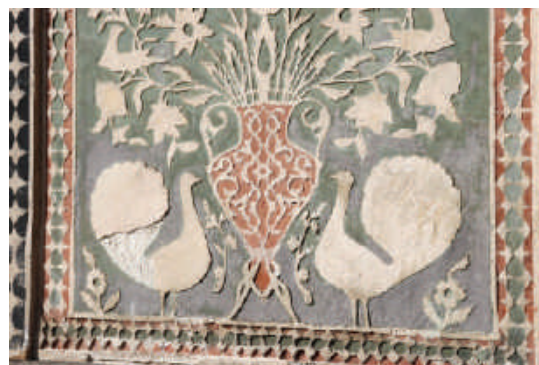
- The floors were made of glazed clay.

- There were numerous gaps in the wall paintings.

- The metal roof structure was dismantled and replaced, but the reinforced concrete beams installed on the façade walls remain. Their removal could cause static problems on the walls. The new wooden roof structure was installed on the transverse walls to reduce the load on the building walls. The roof was covered with stainless steel plates and then ceramic tiles over them. Thus, both the historic appearance of the roof was restored, and it got additional protection from external waters. The beams of the first floor were bolted to the wooden gable structure of the roof.

- The floor beams were inspected, and their decayed parts were restored.

- A new drainage system was installed to discharge rainwater.

- The ground floor used to have had floors made of glazed rammed earth. However, the building is used as a museum, and experts have decided that the floors should

be made of wood, as the dust rising during the movement of tourists leaves damage on the wall paintings. Therefore, the rammed earth floors were replaced with parquet-style hardwood flooring laid over bricks in the corridors and wooden planks in the rooms. The fountain in the central hall on the ground floor was restored.

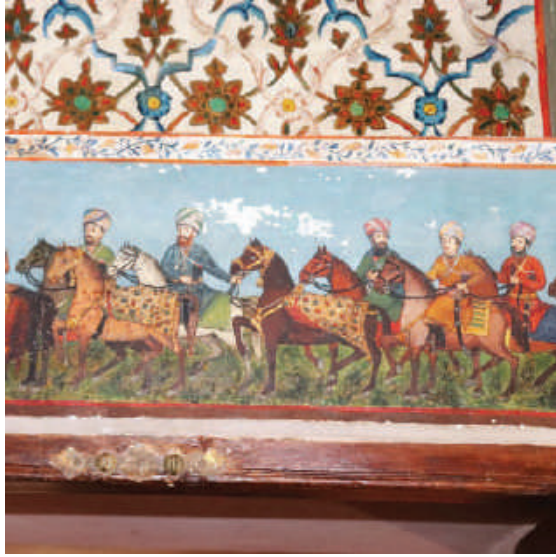
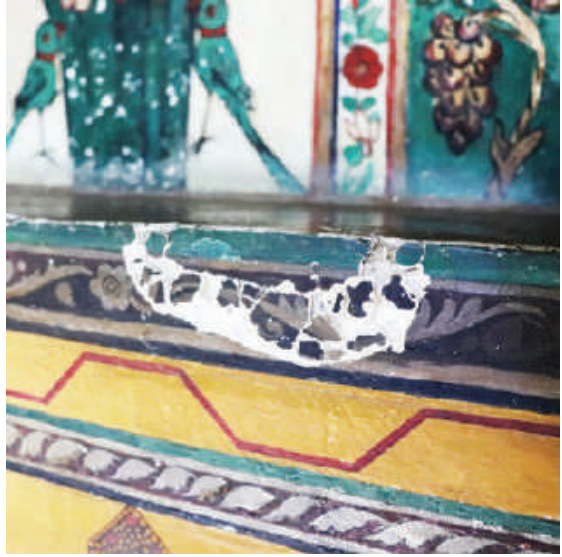
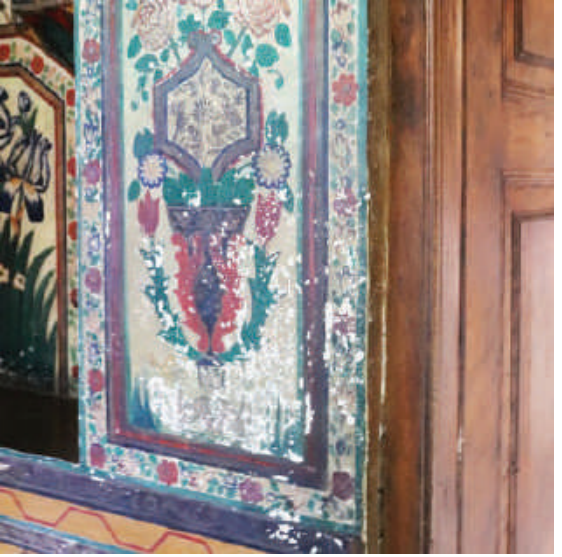
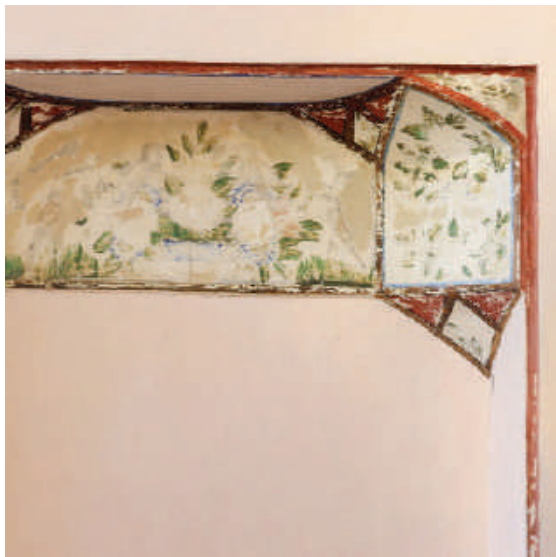
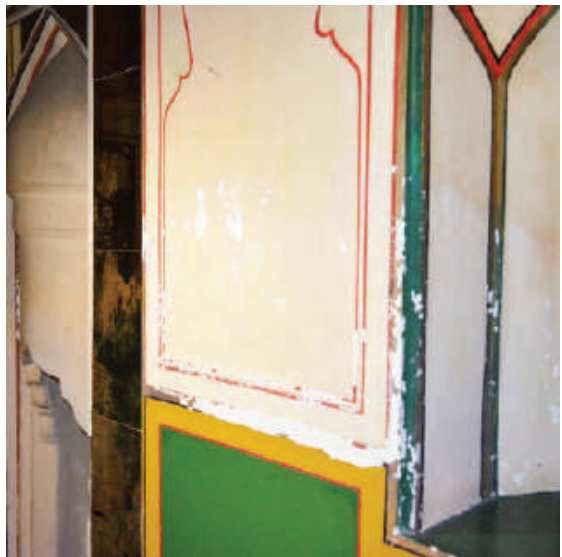
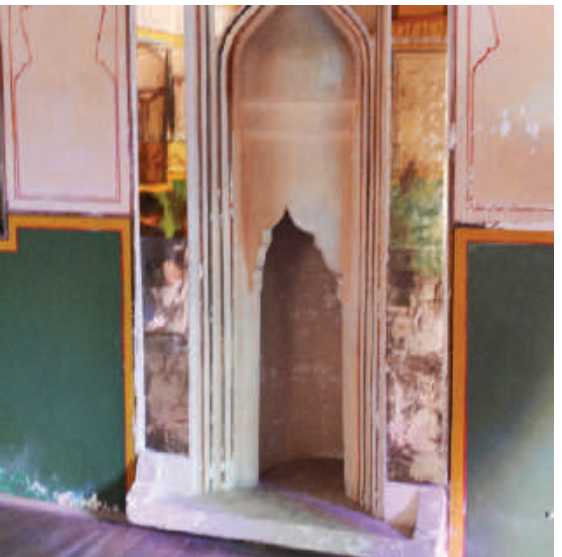
Figure 31. Gaps on the paintings and decorations

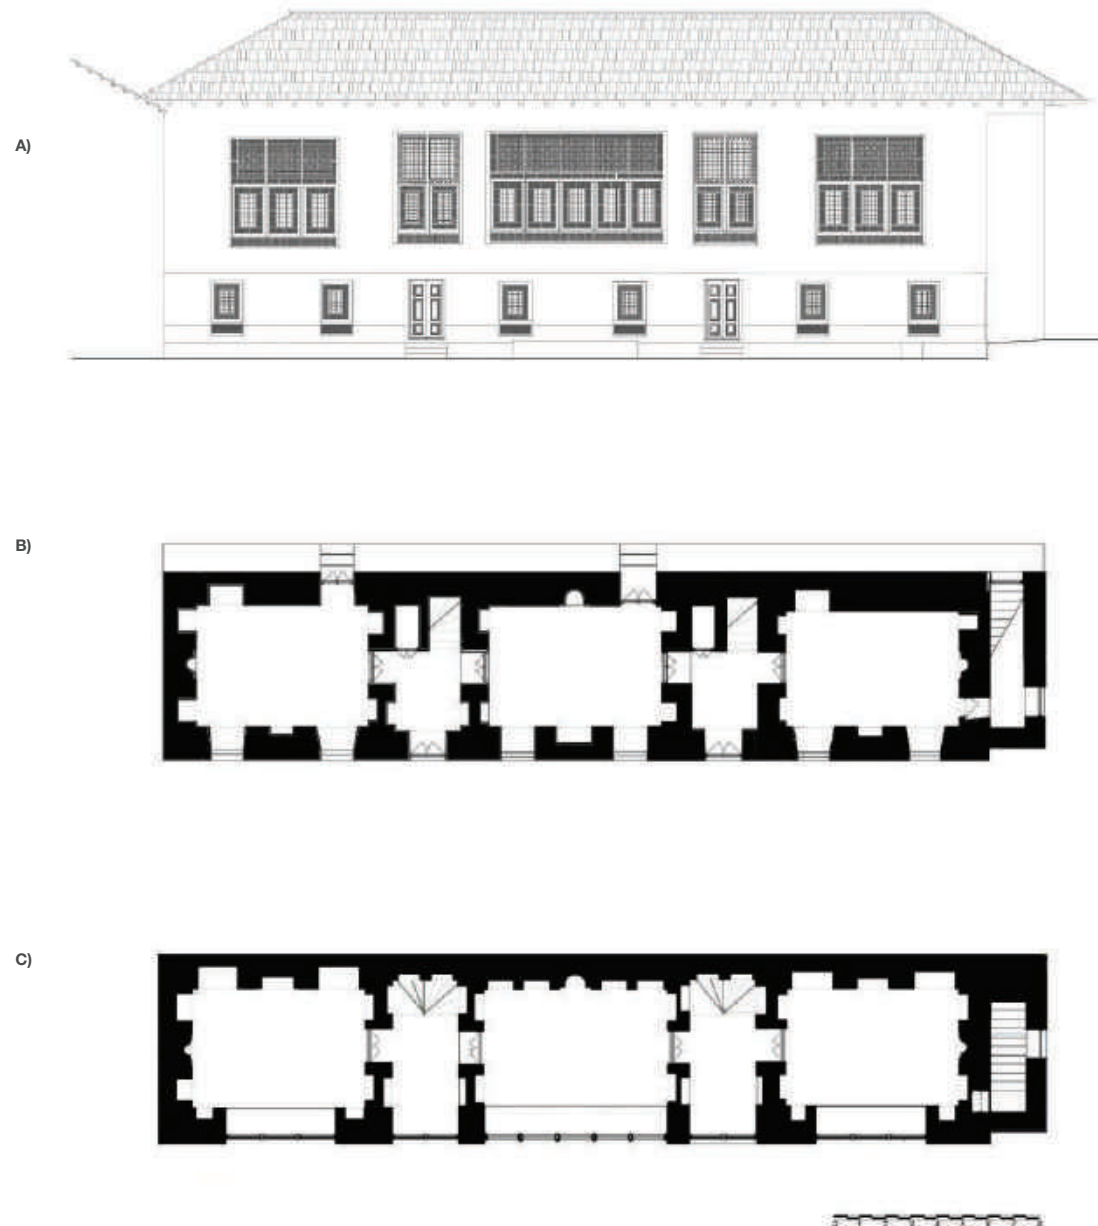
Figure 37. Drawings of the Shekikhanov's House a. Main facade b. Ground floor's plan c. First floor's plan

As the first-floor plan repeats the ground floor plan, the rooms differ for their heights (3,70 m) and decorations. In particular, the decorations of the Central Hall remind of the wall paintings of Sheki Khan's Palace: the wall with a height of 0.94 m without a theme, decorated with recurrent flowers, on the first floor 8 (2+4+2) stalactites were placed on the finished niches. The inner surface of the niches is decorated with portraits, sides, stalactites, and plants with herbal ornaments between the niches. Among the seven niches, the heroes of Nizami Ganjavi's Khamsa poem are depicted against a landscape background. On the right from the central entrance, there is an image of Farhad, then Khosrov, Shirin, Majnun, and portrait compositions of the "Nameless beauty", and on the opposite wall, there are copies of Leyli and the "Slavic beauty" (Miklashevsky, 1949). Four of these portraits are depicted above the waist, in an oval composition, three on their feet, along the figure. "In these images and decorative works, some realist means of depiction show that the artist who drew them is familiar with European painting" (R. Efendi, 2007, p. 121).

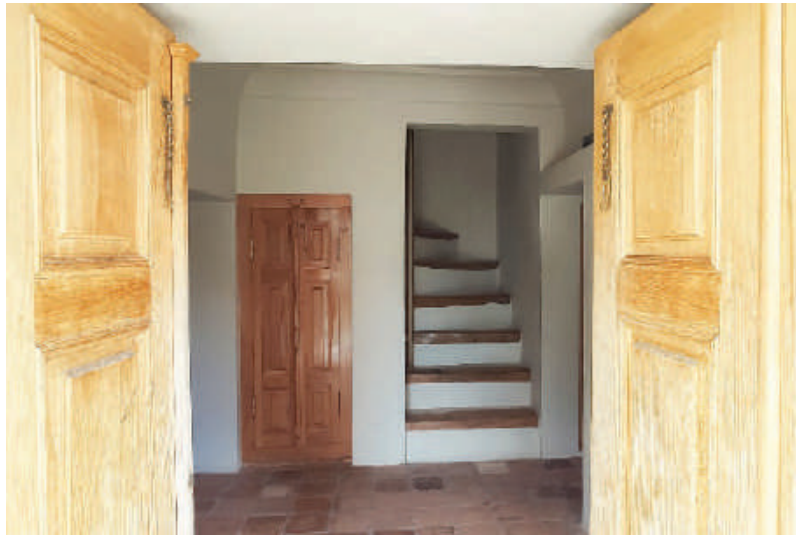
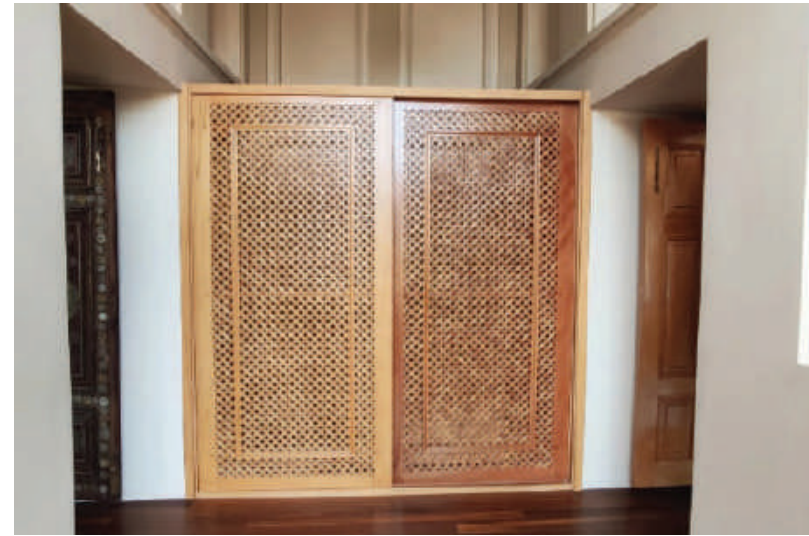
Figure 39. a. Corridor of the ground floor b. Shabaka pattern of the first floor's corridor

In the interior, the upper layer is made of arched finished niches (3-2-3), the lower layer is made of simple rectangular niches. The corridor is separated from the stairs by a wooden lattice curtain. Arches built on wooden beams and plastered several times. There was a transition from the walls to the ceiling with a semi-circular pattern.

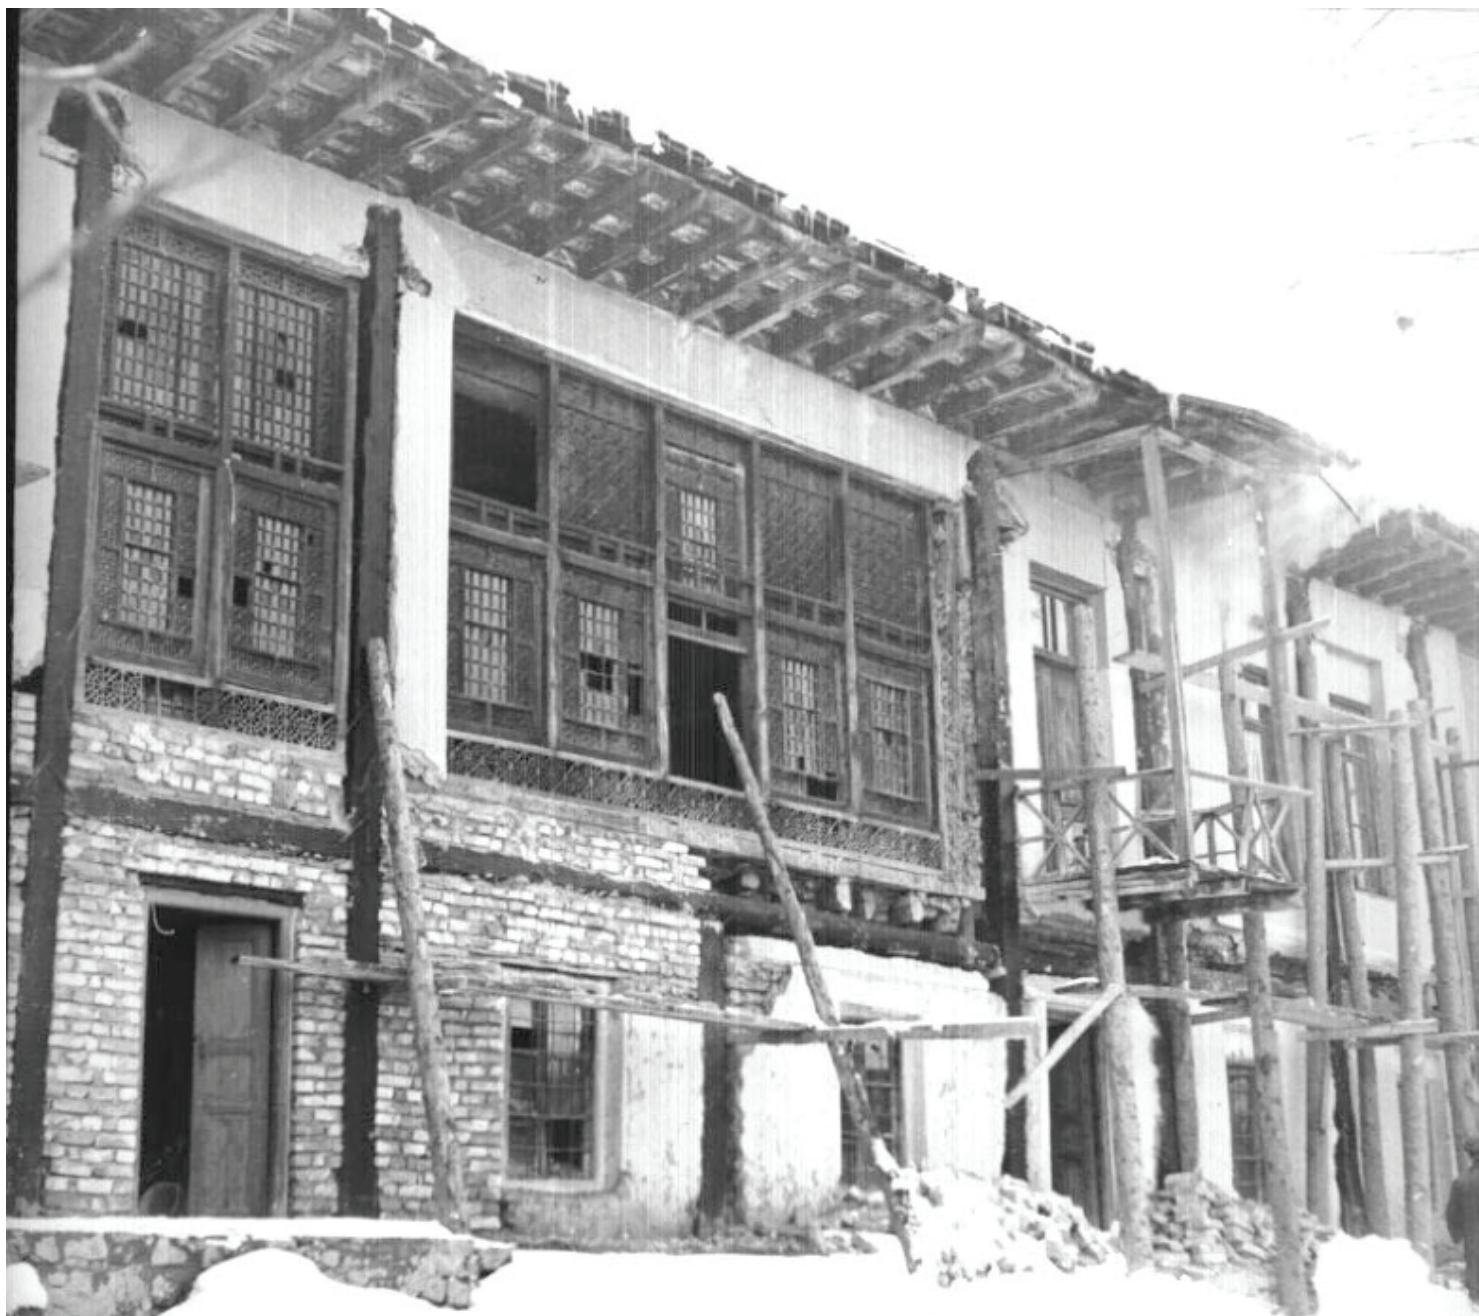
Figure 41. Photo made in 1968 during restoration works

In 1968, in the monument was started the capital measurement work under the leadership of A. Salamzadeh, and the restoration project was developed by N. Rzayev. As the building's constructive system is with wooden carcass-fachwerk, decays have been formed on the board. During this restoration, the trellisworks were uncovered, inspected, additional reinforcing beams were joined in the required places. The same works were carried out on the inter-story beams and roof structures of the building. Roof construction has been completely changed; wooden roofs have been replaced with iron constructions to lighten the roof. According to local architectural traditions, the roof legs were raised 1.2 m from the side of the facade, and wooden boards with colored patterns were laid in this part. During the restoration, the ledges were raised on all three sides of the building (the building was merged from the east side into the residential house), and the patterned wooden boards covered the building from all sides. The main facade networks, doors, arches, steamers have been restored.

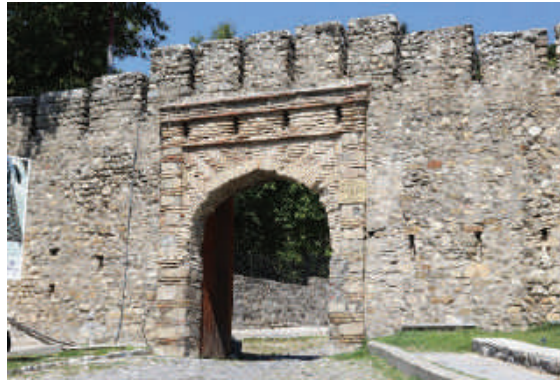
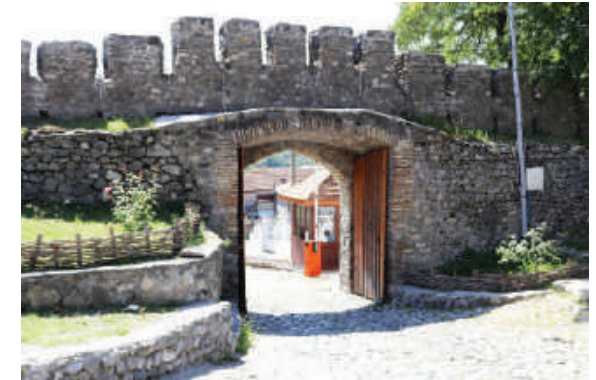
Figure 46. South gate (S.G.) From left to right: a) external appearance; b) internal appearance

There are two gates located in the south and north of the fortress (respectively, the Ganja and Shamakhi gates). The south gate has tiers and over, the door edges are made of baked brick and has brick embrasures. In contrast to the south gate, the north gate has no brick embrasures, and in its interior, the door edges are built in a rock-stone mixture with brick arches. The upper part of the tiers of both gates is built with Herringbone. (Figure 46 and Figure 47)

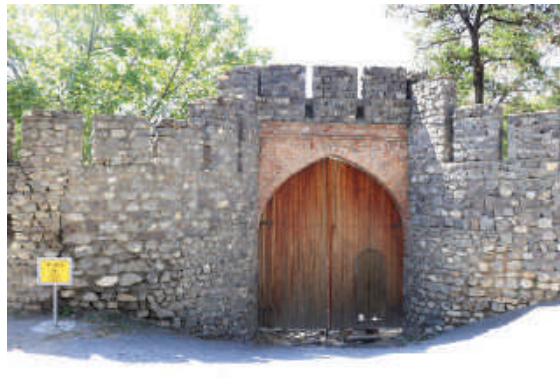
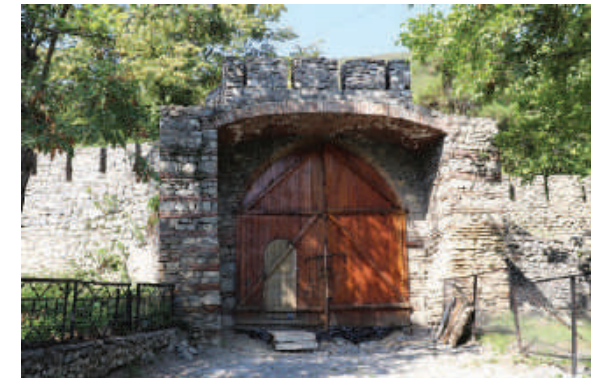
Figure 47. North gate (N.G.) From left to right: a) external appearance; b) internal appearance.

**Northern gate-B1** - It was restored with river stones in the 1960s. Since the stones are built in one layer, it is not durable. It was rebuilt in 2000, as much of it had been dismantled and dispersed. In the section towards the Northern gate, noticeable vertical cracks are observed.

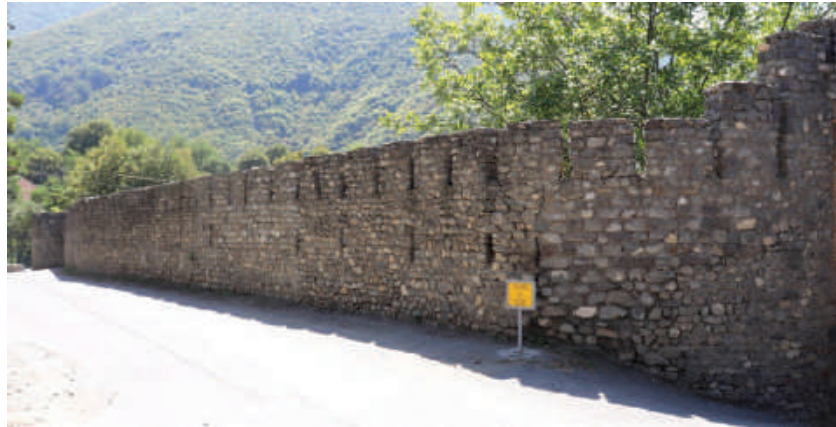
Figure 48. Northern gate -B1 wall

**B1-B15** wall is in an emergency condition. As a result of the rainwater in the guard path was filled into the wall, the wall was demolished and collapsed towards the B15 tower as the wall weakened between the masonry. The opened embrasure “nests” has no access to the guard path. Swelling is observed in some parts of the wall.

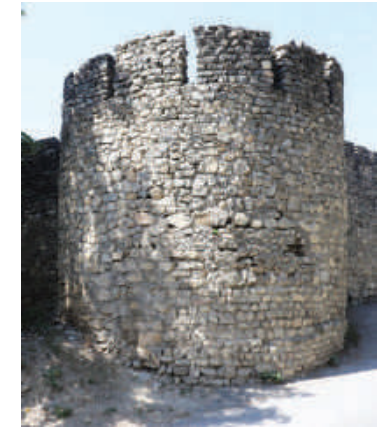
Figure 49. B1 tower

Since most of the **B1** tower was destroyed, it was rebuilt in the 1960s. Noticeable cracks, ruptures, and abrasions are observed on the outer wall.

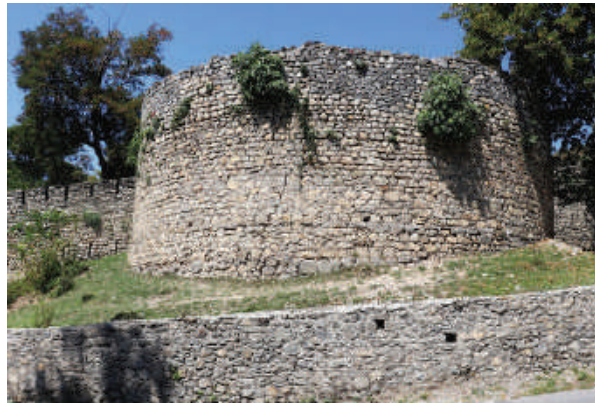
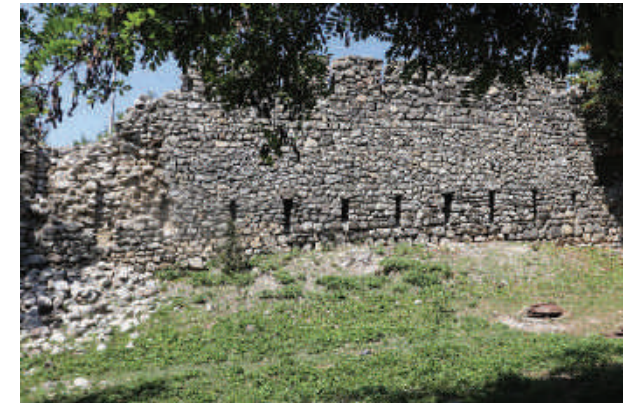
Figure 50. From left to right: 1) B15 tower; 2) B1-B15 wall

Although the **B15** tower has previously had baked brick-tailed gun embrasures such as B3 and B7 towers, at the moment, the upper part of the parapet level is in a demolished state. Since there are abrasions in the foundation, there is a need for reinforcement. In 2007, the parapet part was rebuilt. A vertical crack appears on the tower. The inner part of the masonry should be disassembled and assembled with a cage-metal fixture. Vegetation is observed. There is a pipe outlet on the outer wall of the tower to discharge the inner waters.
