# **CONSERVATION MASTER PLAN** OF THE HISTORIC Center OF SHEKI

The State Tourism Agency of the Republic of Azerbaijan  
**2020**

**Historic Centre of Sheki  
with the Khan's Palace**  
inscribed on the World  
Heritage List in 2019

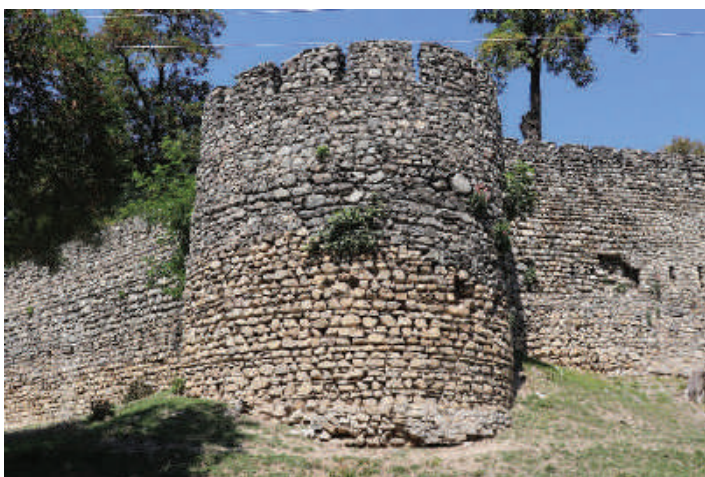
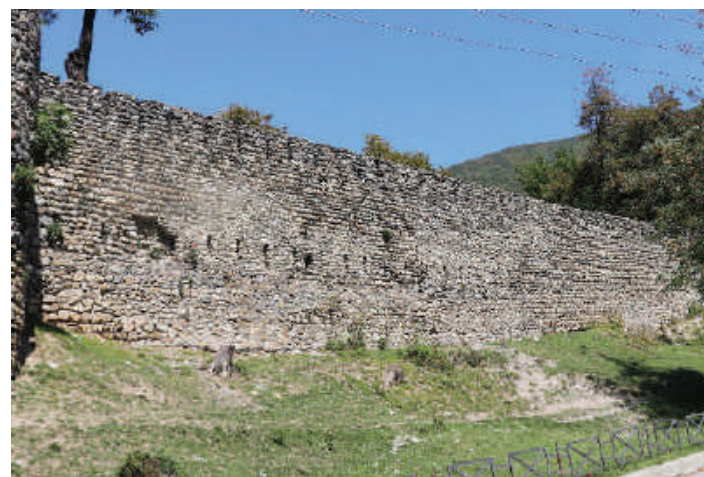
Figure 51. From left to right: a) B14 tower b. A wall between the B15-B14 towers

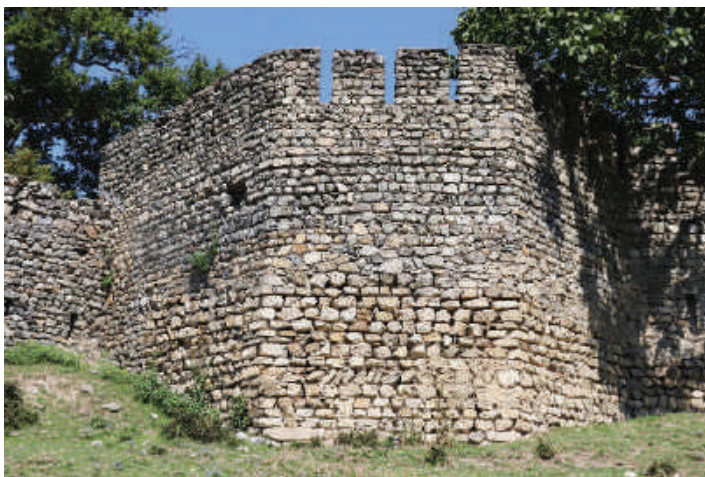
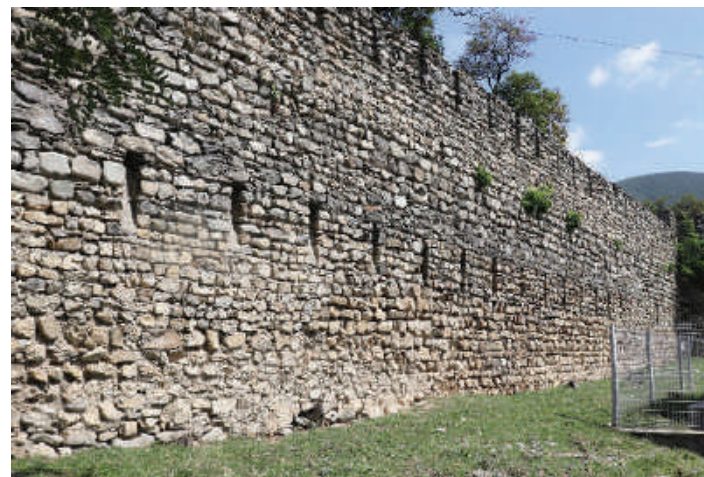
Figure 52. a. B13 tower b. A wall between the B14-B13 towers

The outer wall of the **B13 tower** is made of 2 rigid steps. Although the rock stones were broken and used in the original part of the tower and covered with rigid corners, the angular corners (fillets) were formed in the later restored upperparts. Vegetations and ruptures are observed.

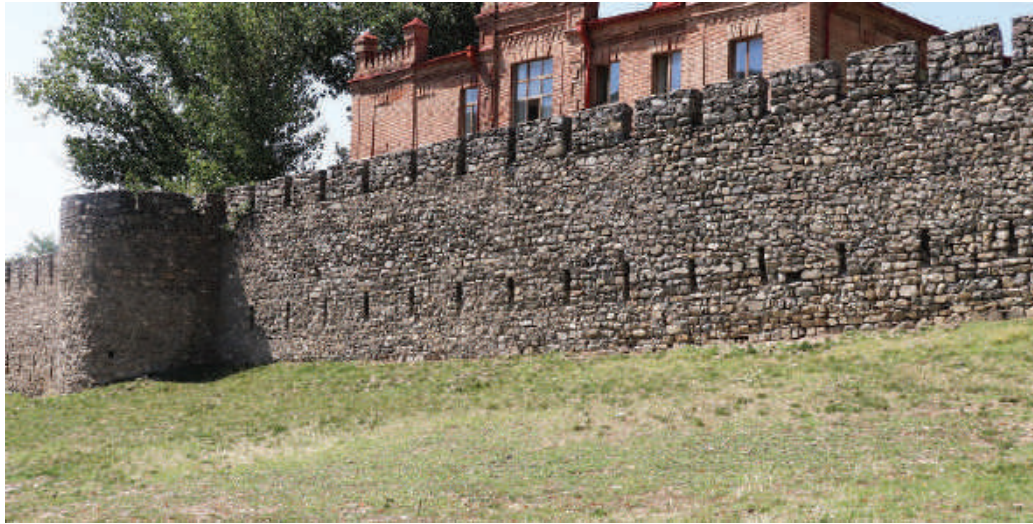
Figure 53 a. A wall between B11-B12 towers b. B12 tower

Upper part of the **B12-B11** wall was prevented from demolition in the 1980s. Merlons were built in 2007 on the top of the wall towards **B12** with river stone. A noticeable crack appears over the B12 tower.

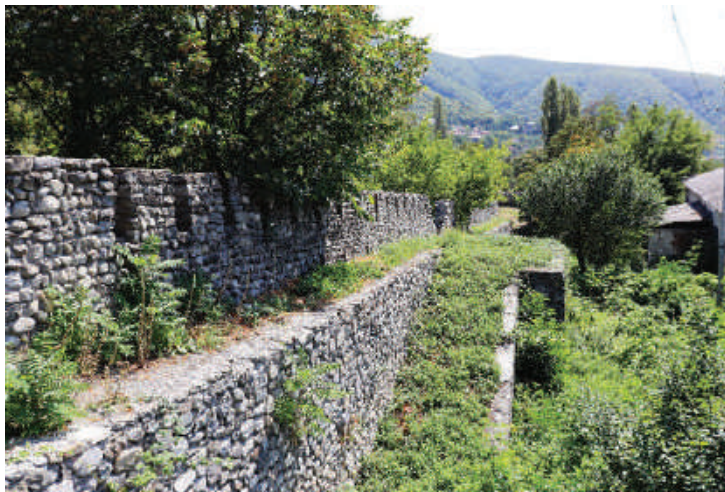
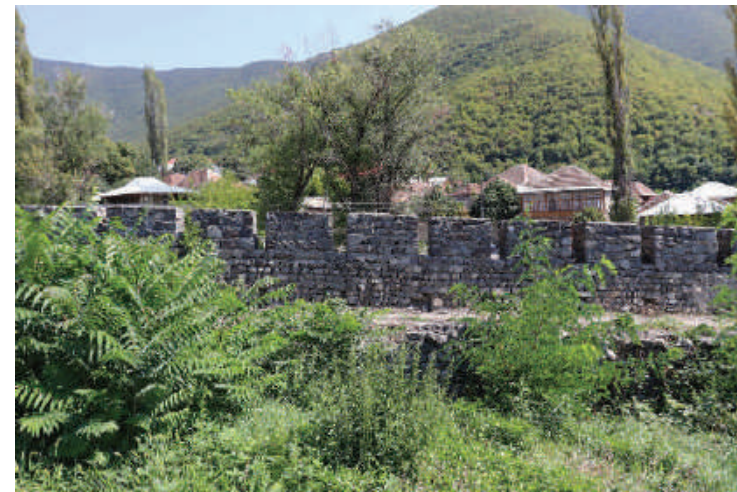
Figure 54 a. Inner appearance of B1-B15 wall b. Inner appearance of B12-B11 wall.

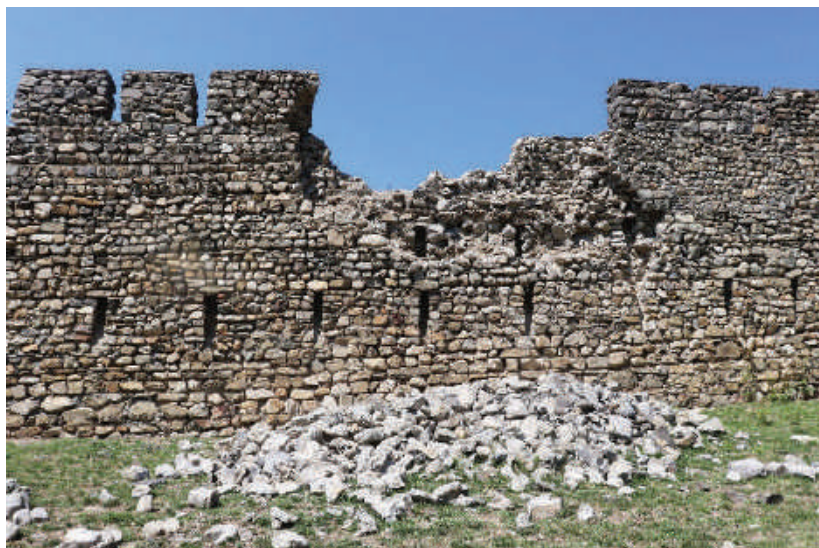
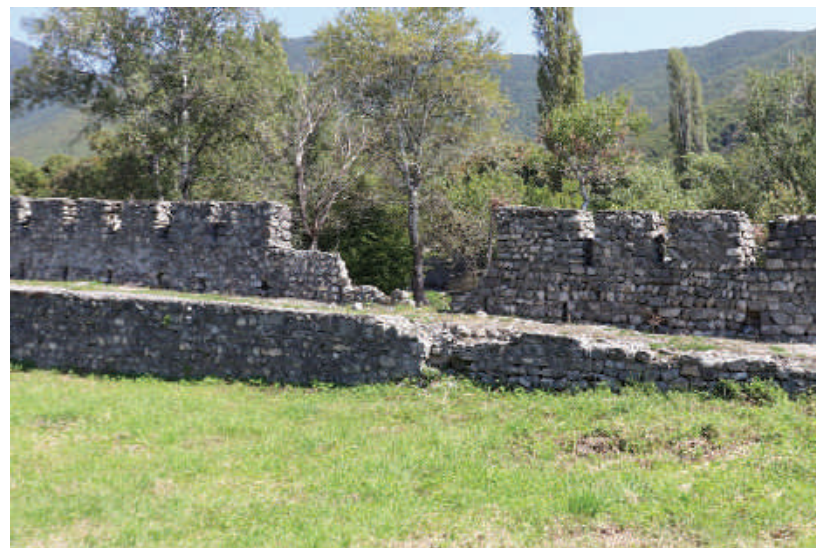
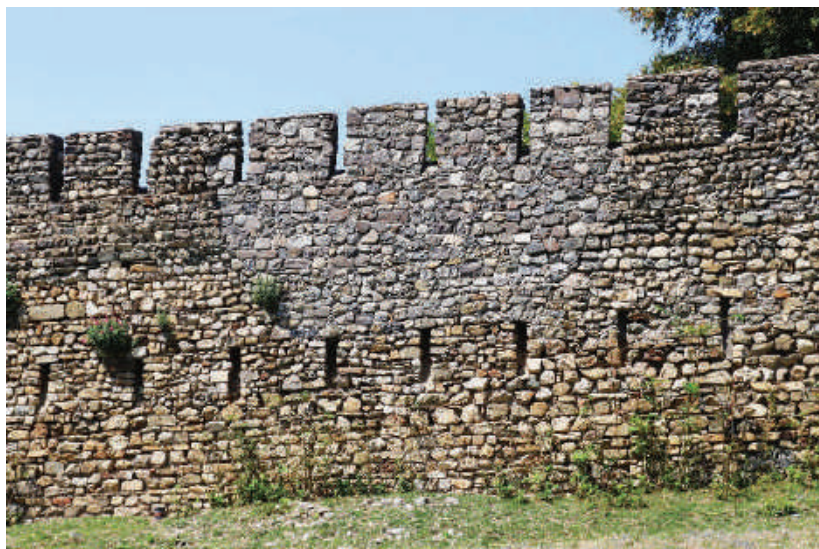
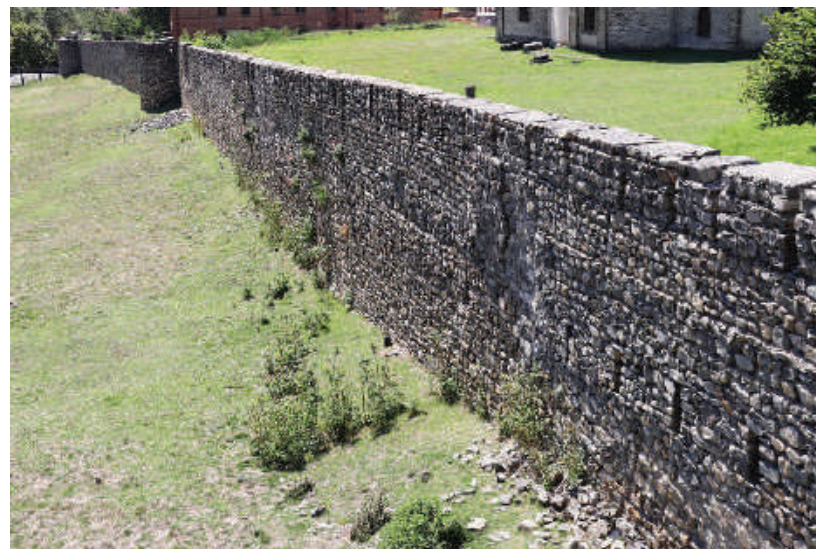
Figure 55. a wall between the B13-B12 towers a.b. demolished part of parapet and external wall c. Part restored in 2009. d. B13 tower appearance

**B1-B15** wall is in an emergency condition. As a result of the rainwater in the guard path was filled into the wall, the wall was demolished and collapsed towards the B15 tower as the wall weakened between the masonry. The opened embrasure “nests” has no access to the guard path. Swelling is observed in some parts of the wall.

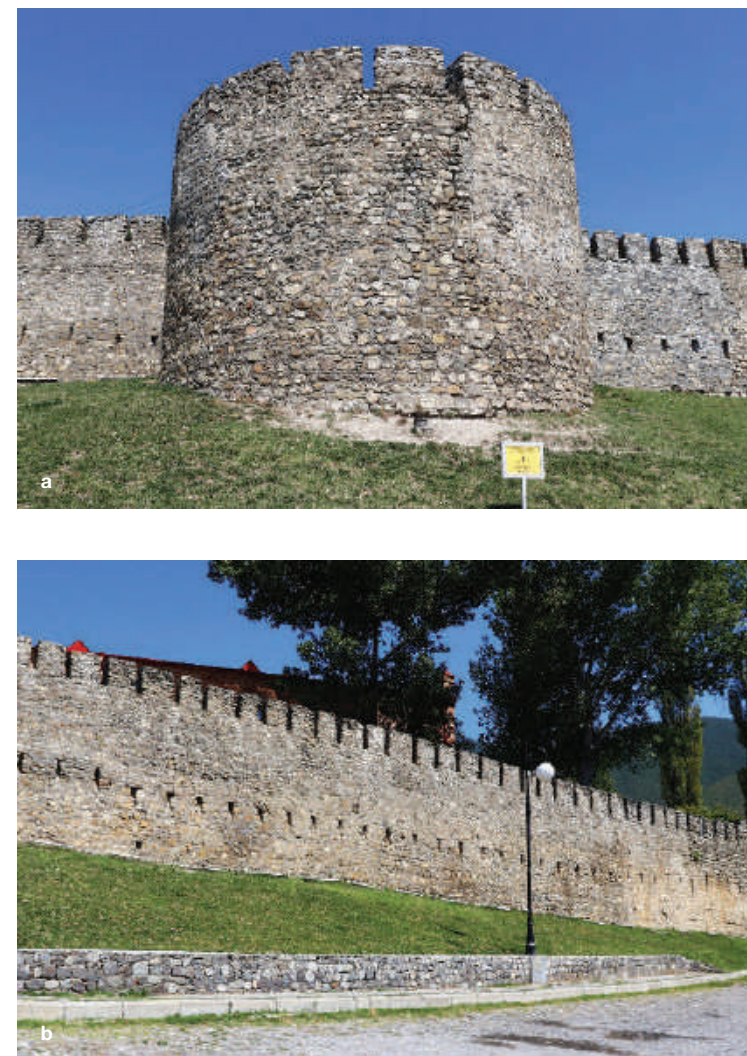
Figure 56. a. B9 tower b. B10-B9 wall

The span of the **B10-B9** wall was renovated in the 1980s. Towards the tower of B9, the masonry was

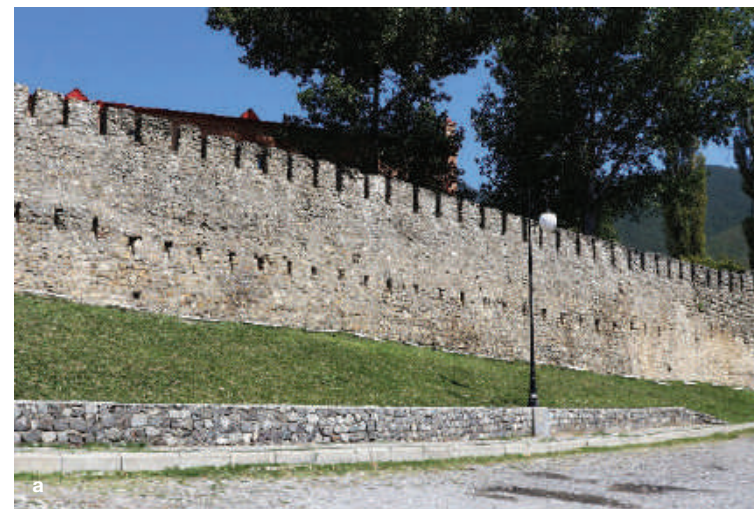
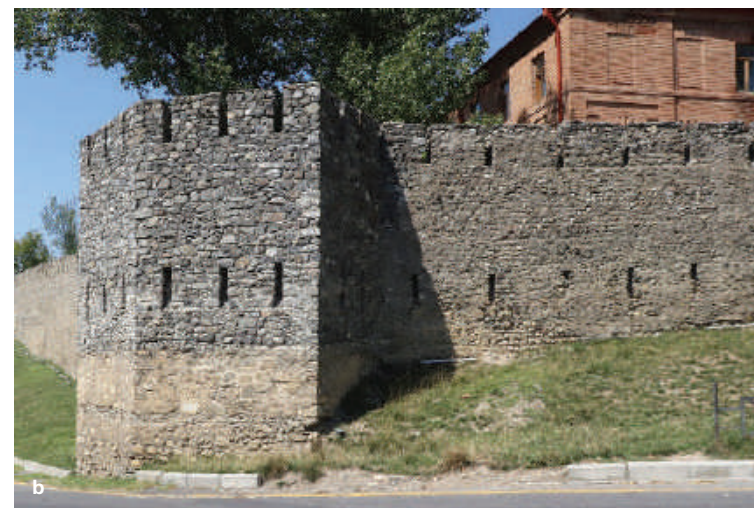
Figure 57. a. B10-B9 wall, b. B10 tower and B11-B10 wall

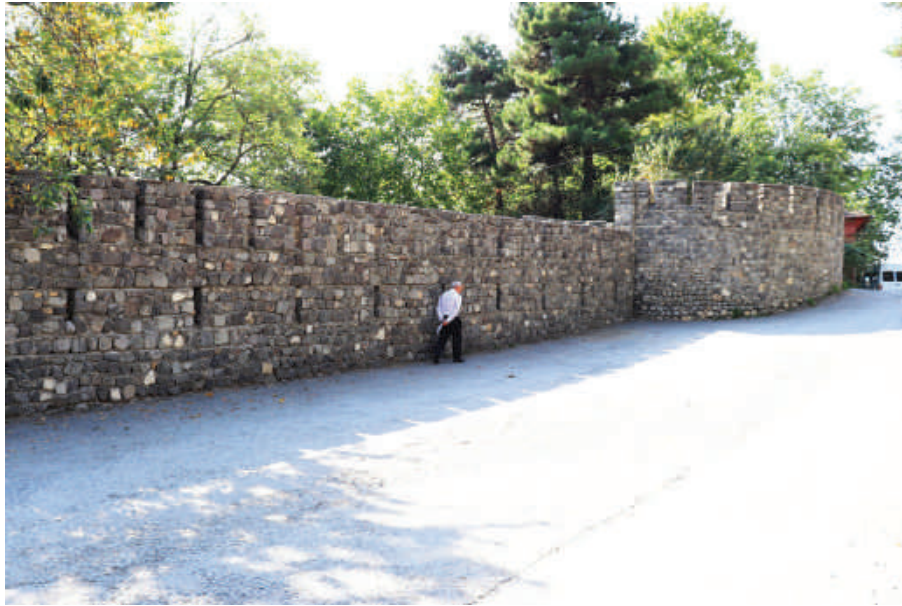
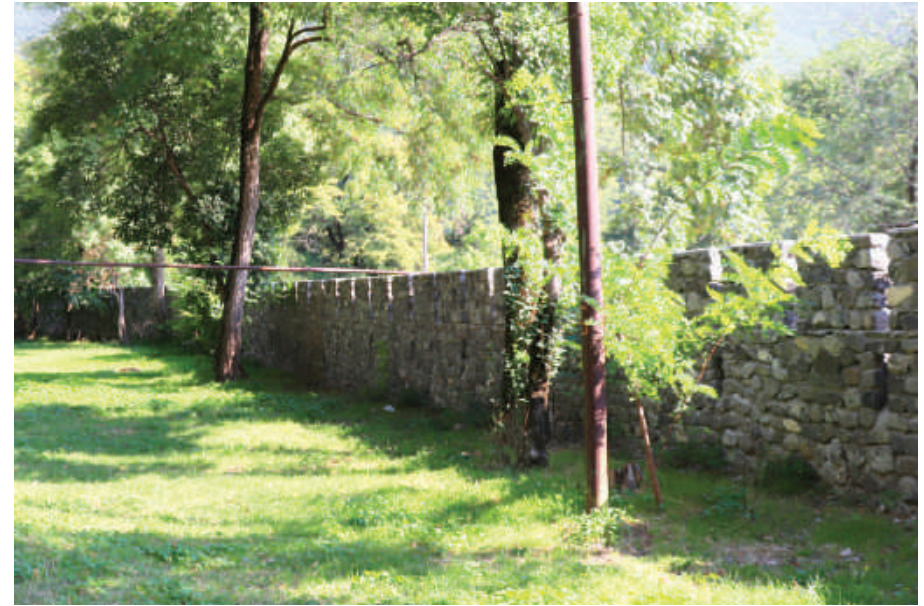
Figure 58. a. N.G-B2 wall and B2 tower b. B2-B3 wall

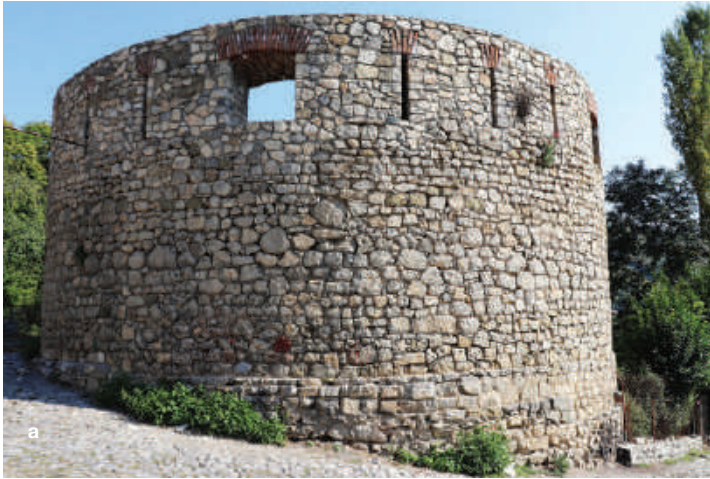
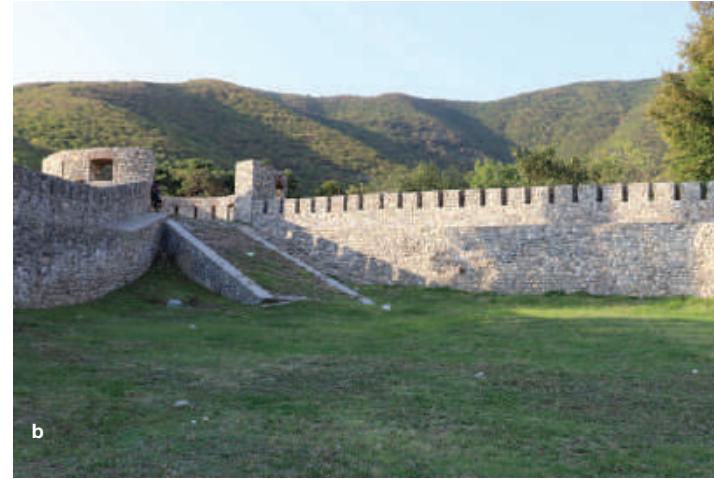
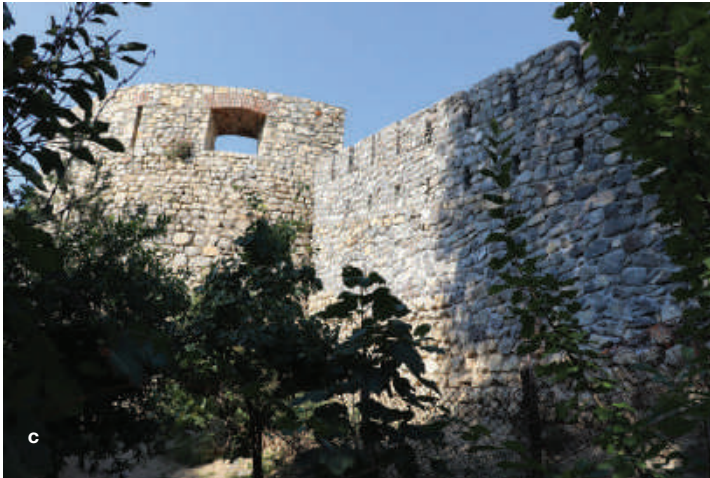
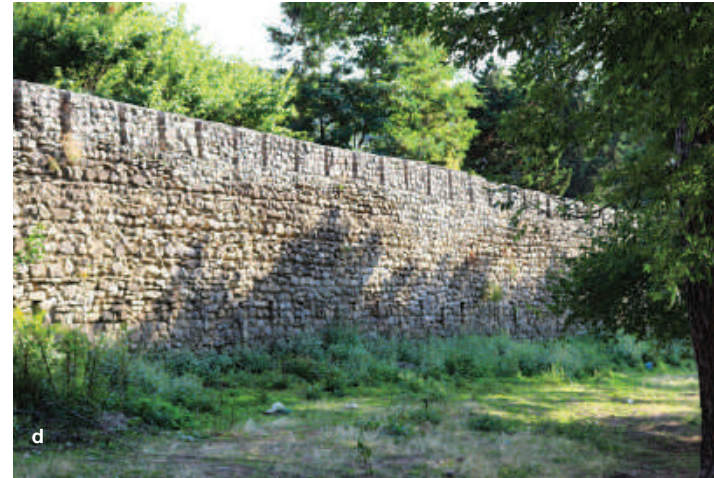
Figure 59. a. B3 tower from outer part b. B3 tower from inner part c. B3-B4 wall d. B4-B5 wall

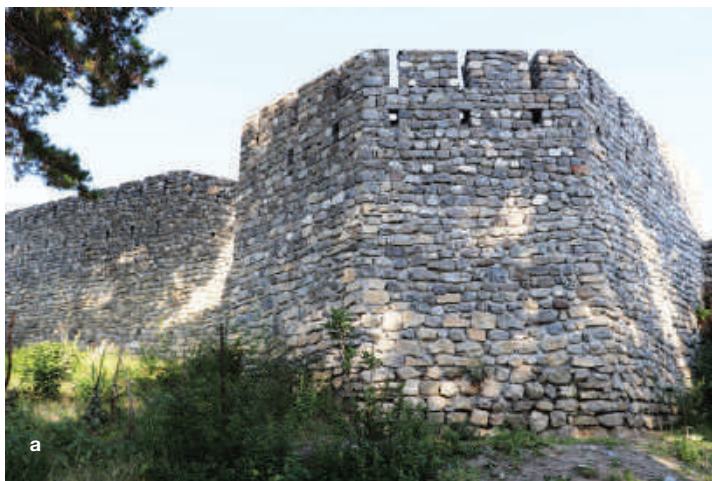
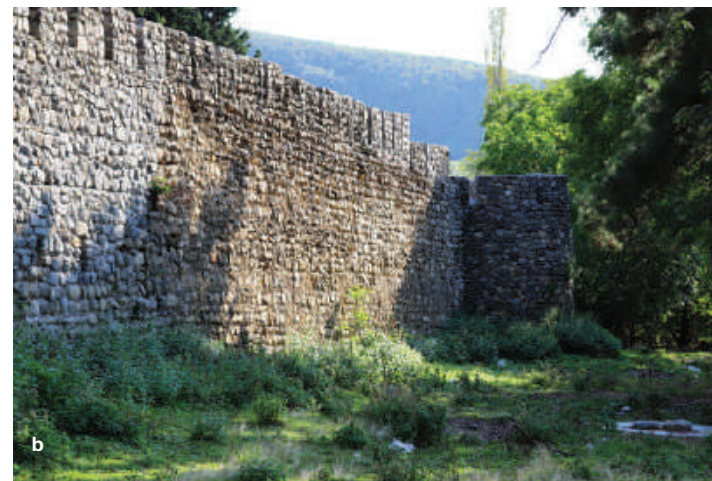
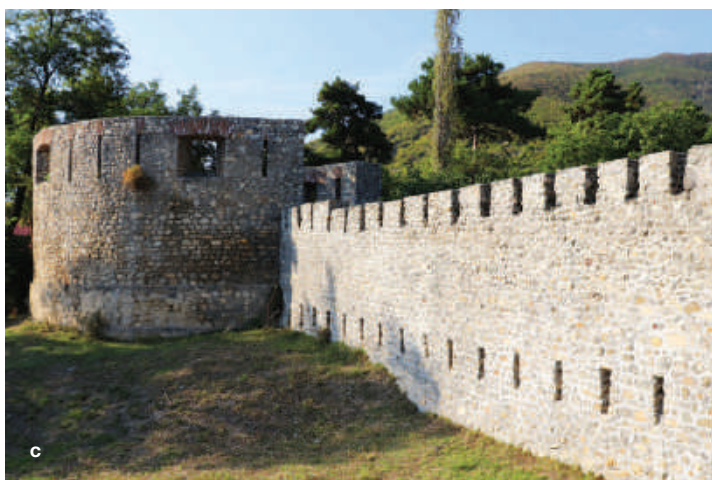
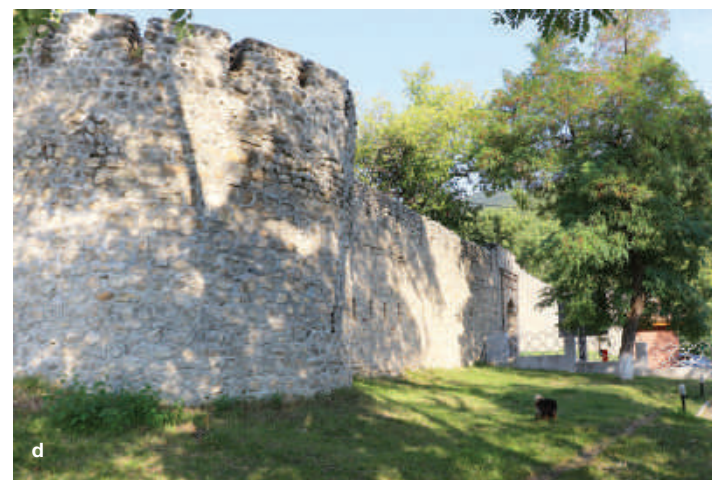
Figure 60. a. B5 tower b. B5-B6 wall and B6 tower c. B7 tower and B7-B8 wall d. B8 tower and B8-S.G. wall

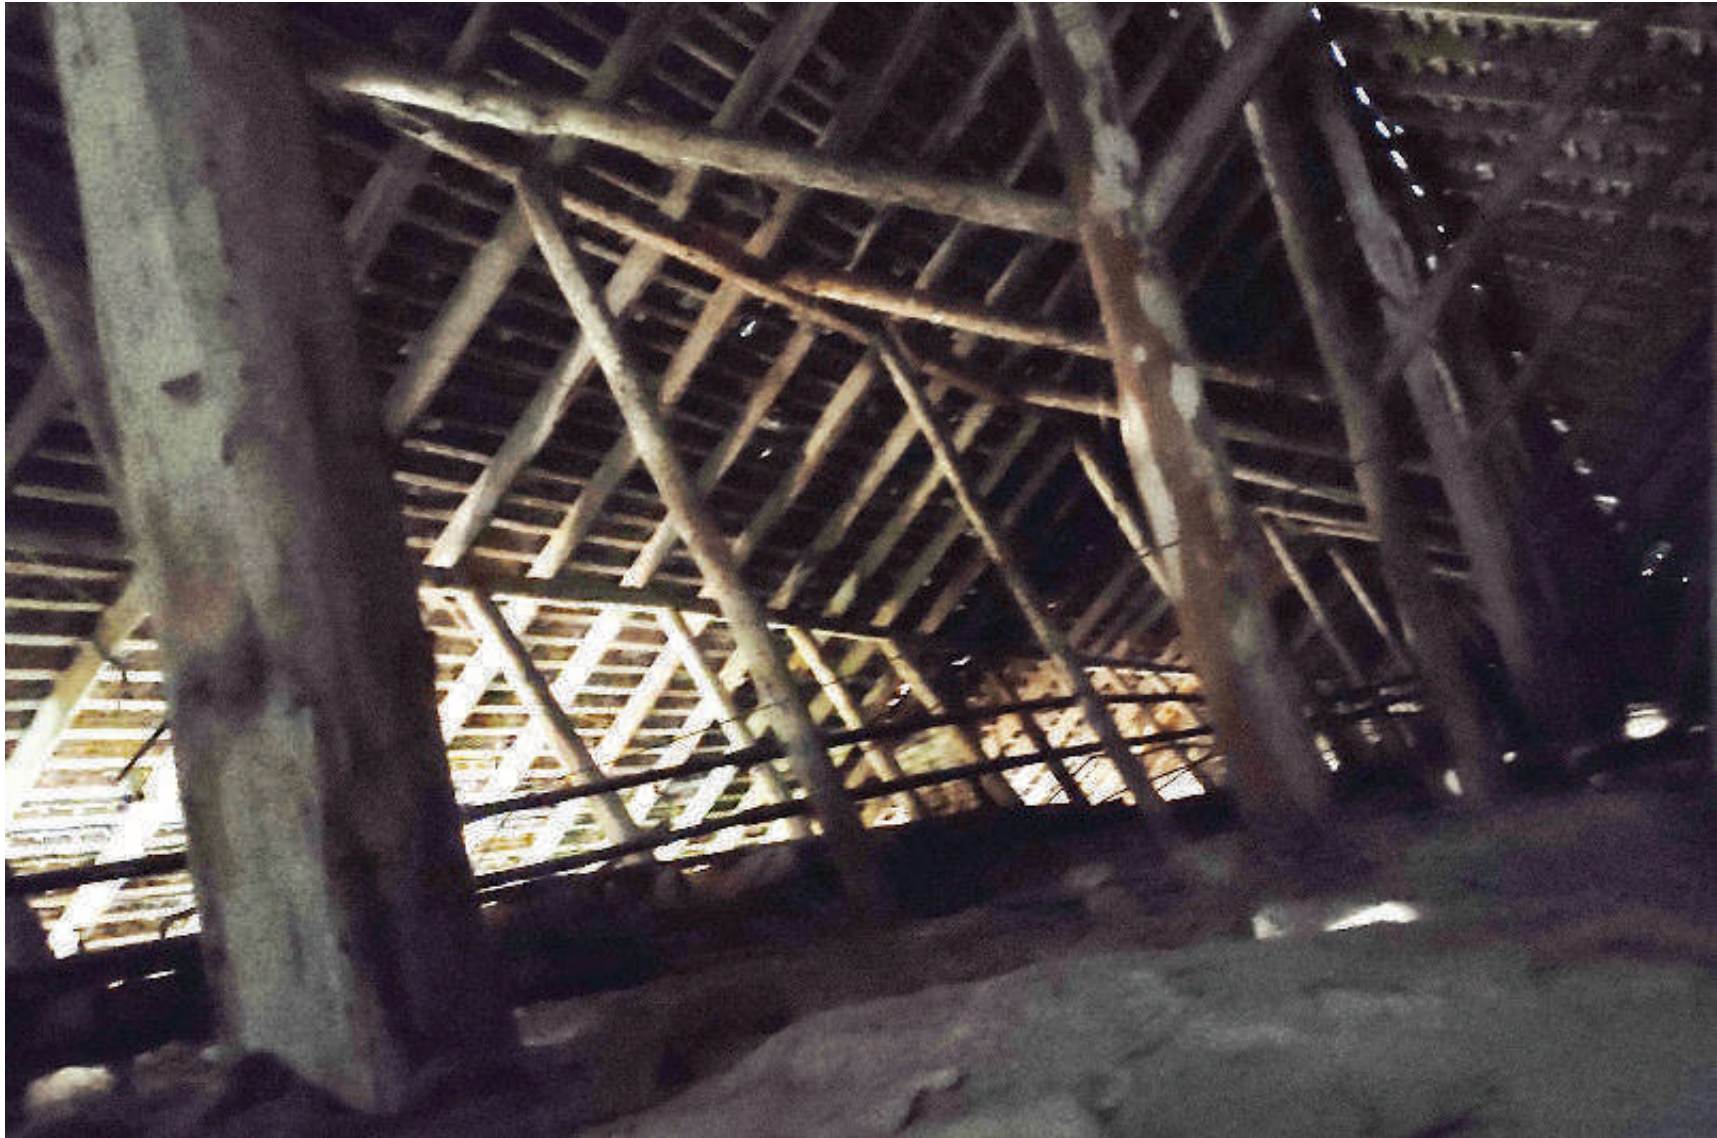
Figure 67. View of the garret

- During its activity since 1991, major repair and restoration has not been carried out.
- Deformations, cavities are observed on the roof, especially on the wooden construction.
- Decay and pollution are observed on the roofing part.
- Masonry of the walls did not correspond to the historical appearance of the monument, abrasion was observed in many areas.
- Abrasion was observed in doors and windows.
- All elements of the kitchen part and restaurant block - doors, windows, hand-rails and other wooden elements are outdated and deformed as a product of the restoration of 1986. Also, their appearance also does not match the historical look.
- For a long time, the basement rooms have remained unused. It was used as a warehouse in the past.

- Missing tiles on the roof should be added.
- Reconstruction of communication lines is required.
- The walls and ceiling of the kitchen are blackened. They must be overhauled.

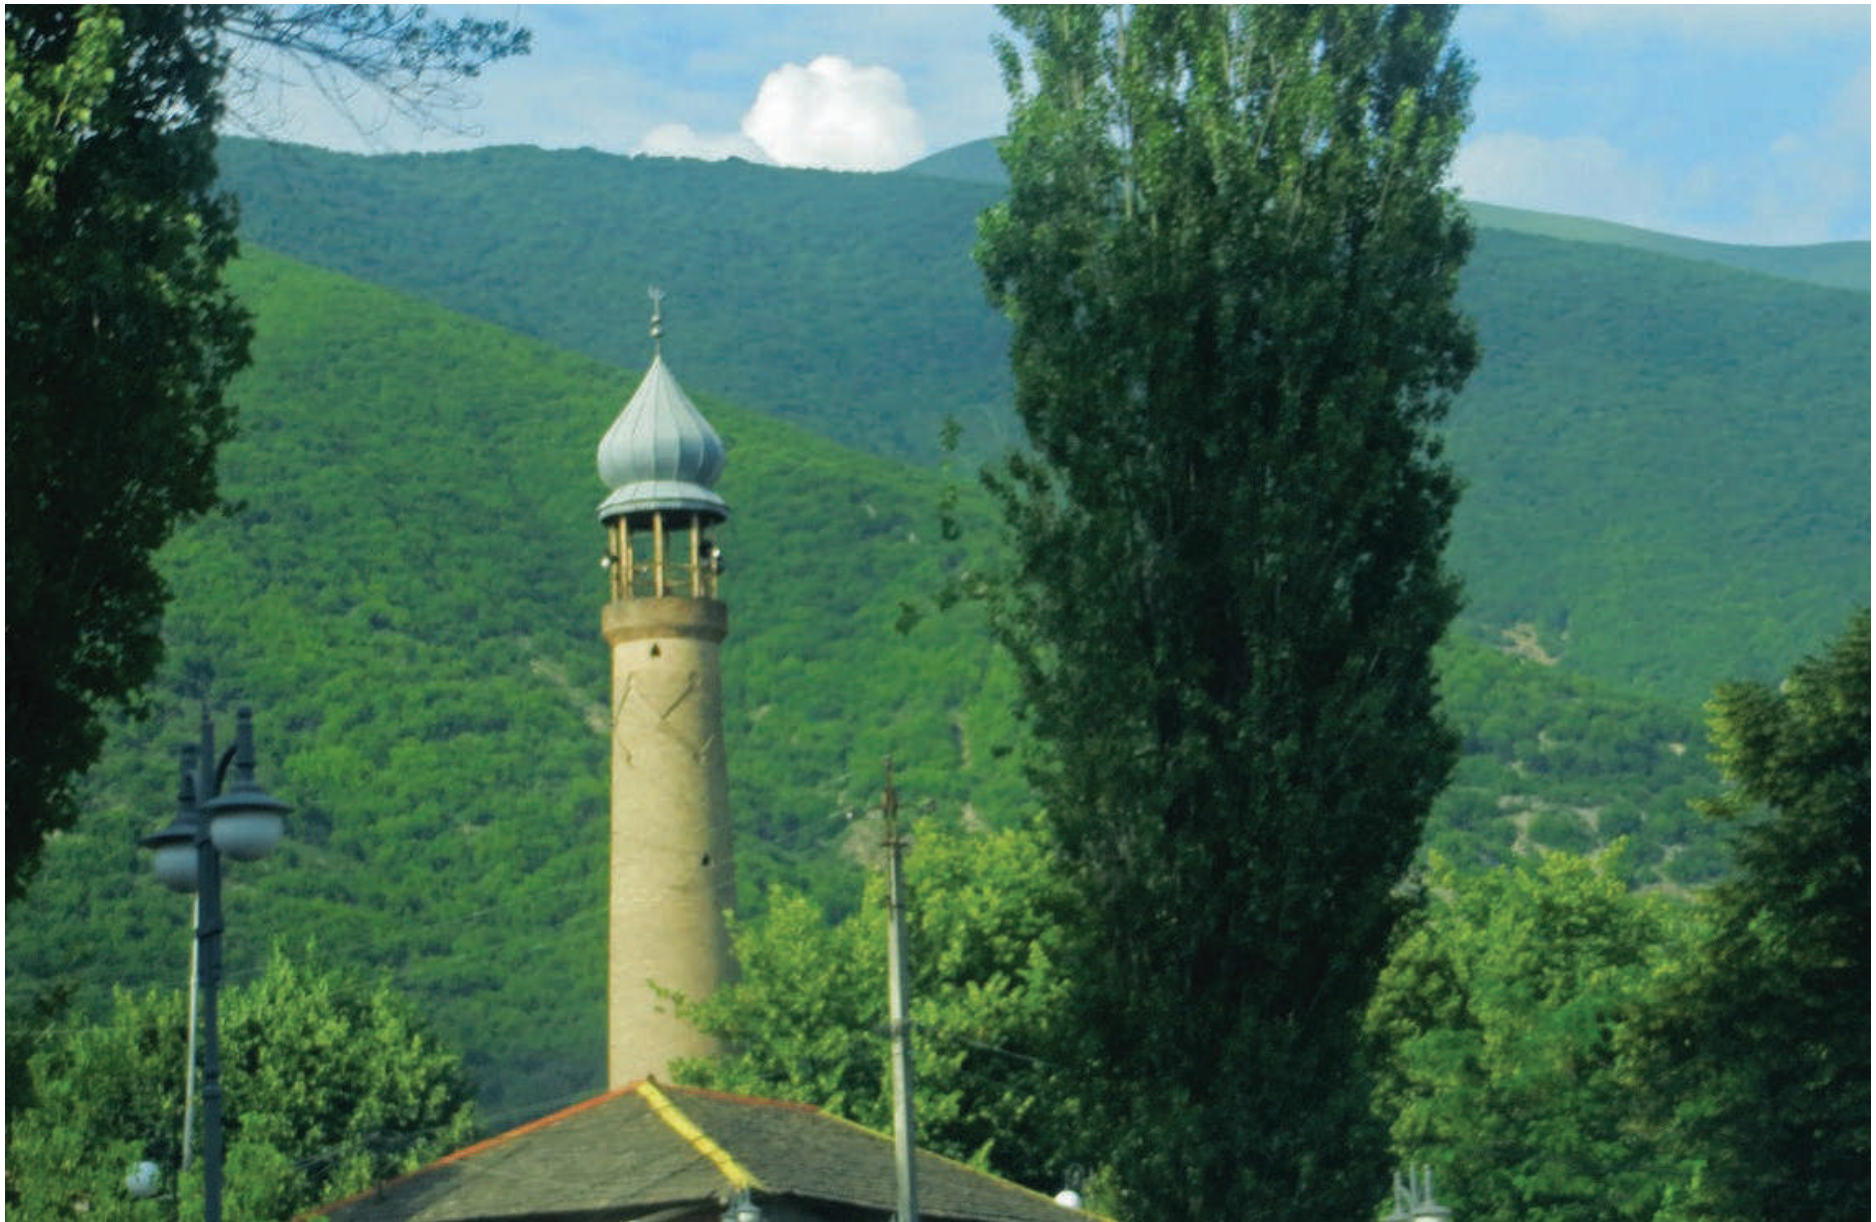
Figure 68. The minarets, like in Imam Ali Mosque, have an important place in the composition of mosques, they are distinguished by 25-40 m vertical lines against the rich greenery of the gardens and low-rise residential houses.

be the visit to the minarets. These, raised over the city, offer particular viewpoints. Continuous maintenance is recommended (Fig. 68).

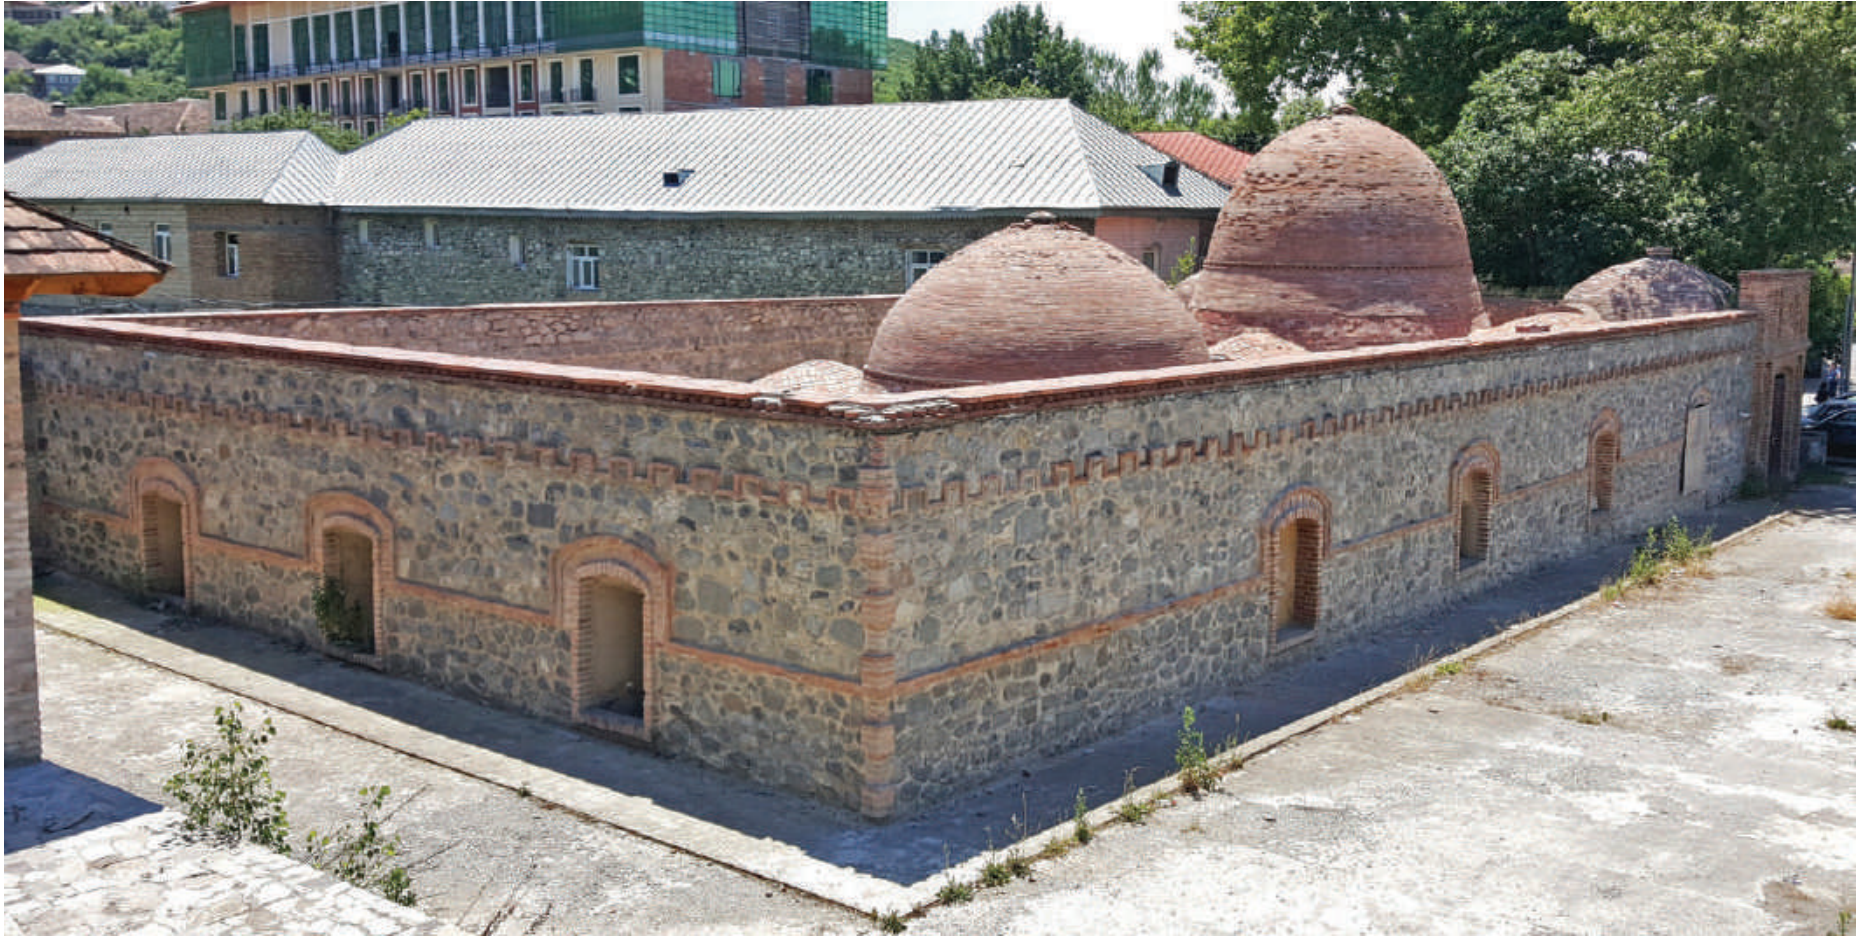
Figure 70. The façade has vertical divisions where the windows and the portals all have a terracotta brick decoration, as the Abdul Salam Hammam. It should be noted that restoration work in this bath has not been completed. Sheki hammams are covered with cross roofs like dwellings.

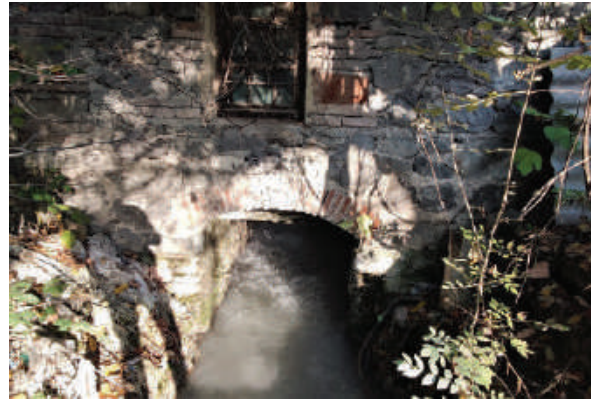
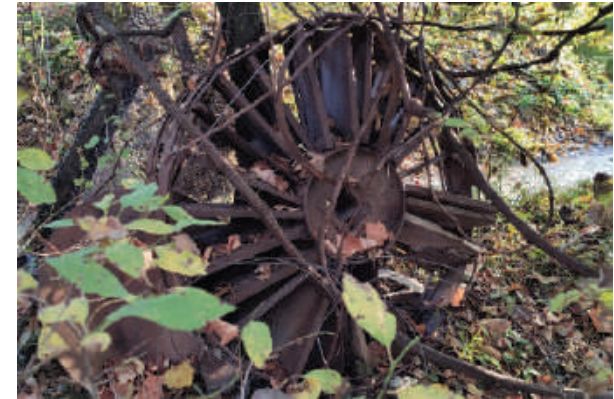
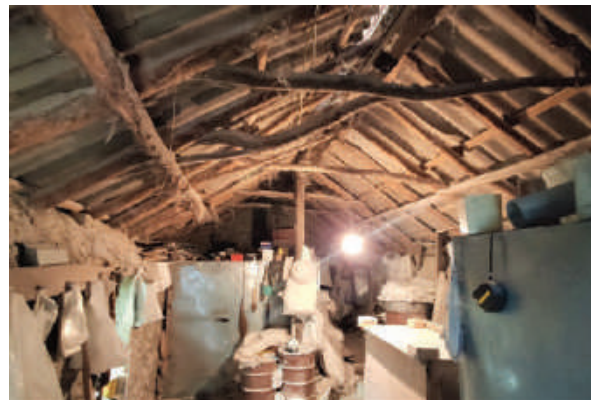
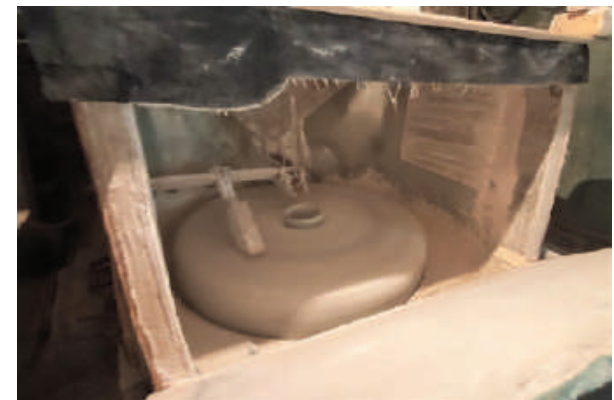
Figure 75. Photos of Water mill N.2

The exterior walls are made of river stone and bricks. The roof has been covered with corrugated asbestos roofing sheets. The wooden structure of the roof is built with rough timbers. There are two wheel-chambers in the mill, one of which is broken and not functioning.

In the late renovation, limestone blocks are used in the corners of the building to strengthen its structural integrity. Extension to the building is built to expand the storage area. Currently, it needs to get renovated. The metal gate is used for the entrance to the site, which does not comply with architectural typology.

Roof structure and asbestos roofing material need to get changed to roof tiles. Ruptures on the wall masonry must be fixed with the same kind of stone. The door and windows need to get replaced with appropriate ones. The site around the mill should be rethought and the concept for the mills should be redeveloped. It is possible to fix the second wheel chamber which will bring the mill to the fully working condition. The interior also needs a retouch. The small canal which brings water into the mill should get renovated.

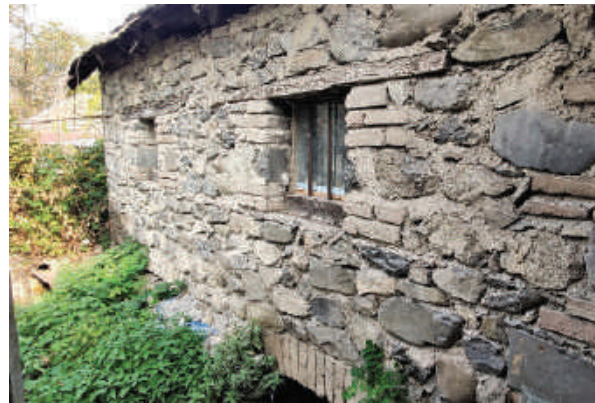
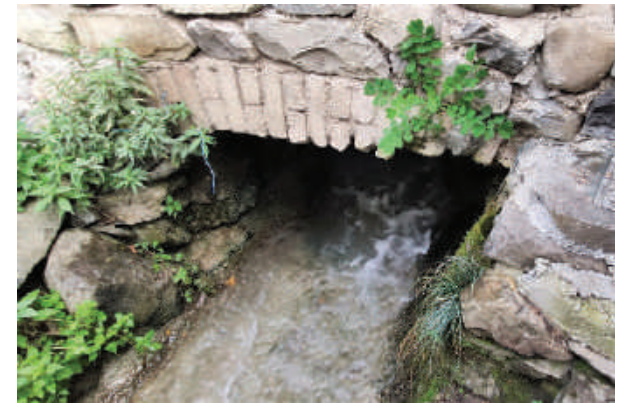
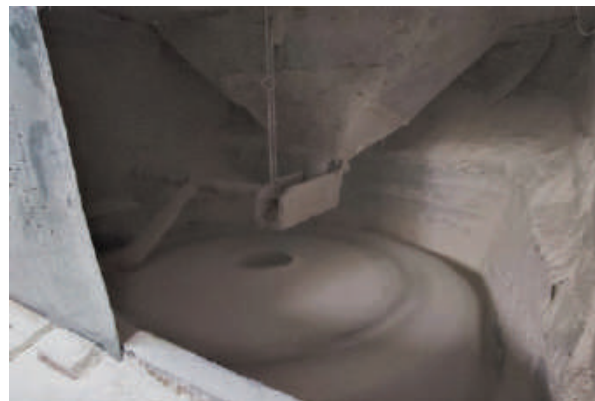
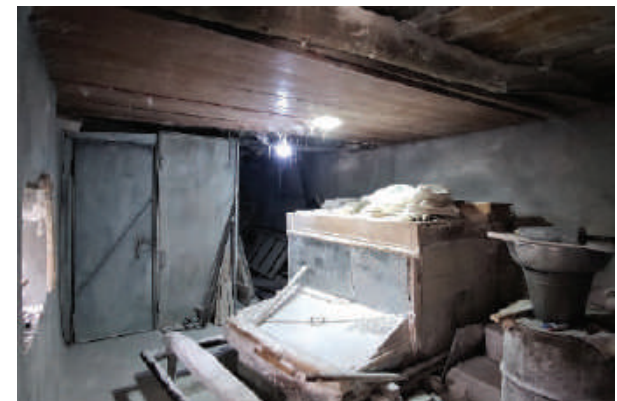
Figure 77. Photos of Water mill N.5

The exterior walls are made of river stone and bricks and interior side of the walls is mortared. The roof has been covered with roof tiles. Some of these tiles are missing and some need to be replaced. There are 2 wheel chambers in the mill, one of which is broken and not functioning. It is possible to fix the second wheel chamber which will bring the mill to the fully working condition. Extension to the building is built to expand the storage and technical areas. There is a garage in front of the mill which blocks the main entrance. Removing it would open up area around the mill and could accomodate public space as well.

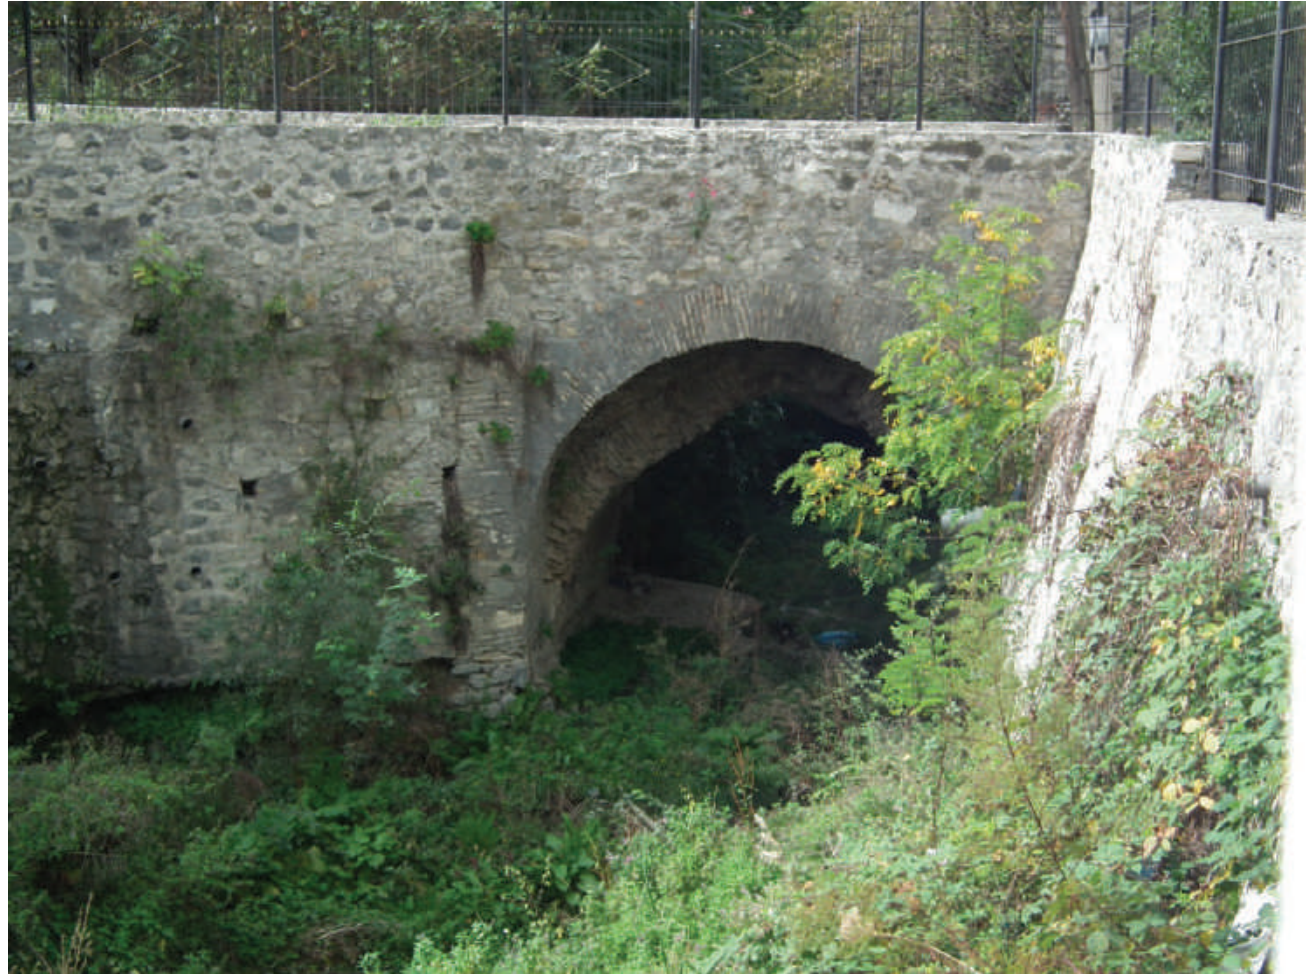
Figure 78. Arched bridge

Bricks and lime were used in the construction of these bridges. In order to reduce the speed of the water, throws (beams) were built in the River; fences were laid on the walls of the river. Although the bridges' load bearing properties are very high, in recent years, their constructive dimensions have deteriorated as a result of abrasions.

Out of four, in three bridges, the allowed speed limit of 20 km per hour and 7 ton of weight of vehicles at maximum is determined. However, in one of them (bridge next to School No.3), all kinds of vehicles are prohibited considering its load-carrying capacity, and only pedestrian use is allowed.

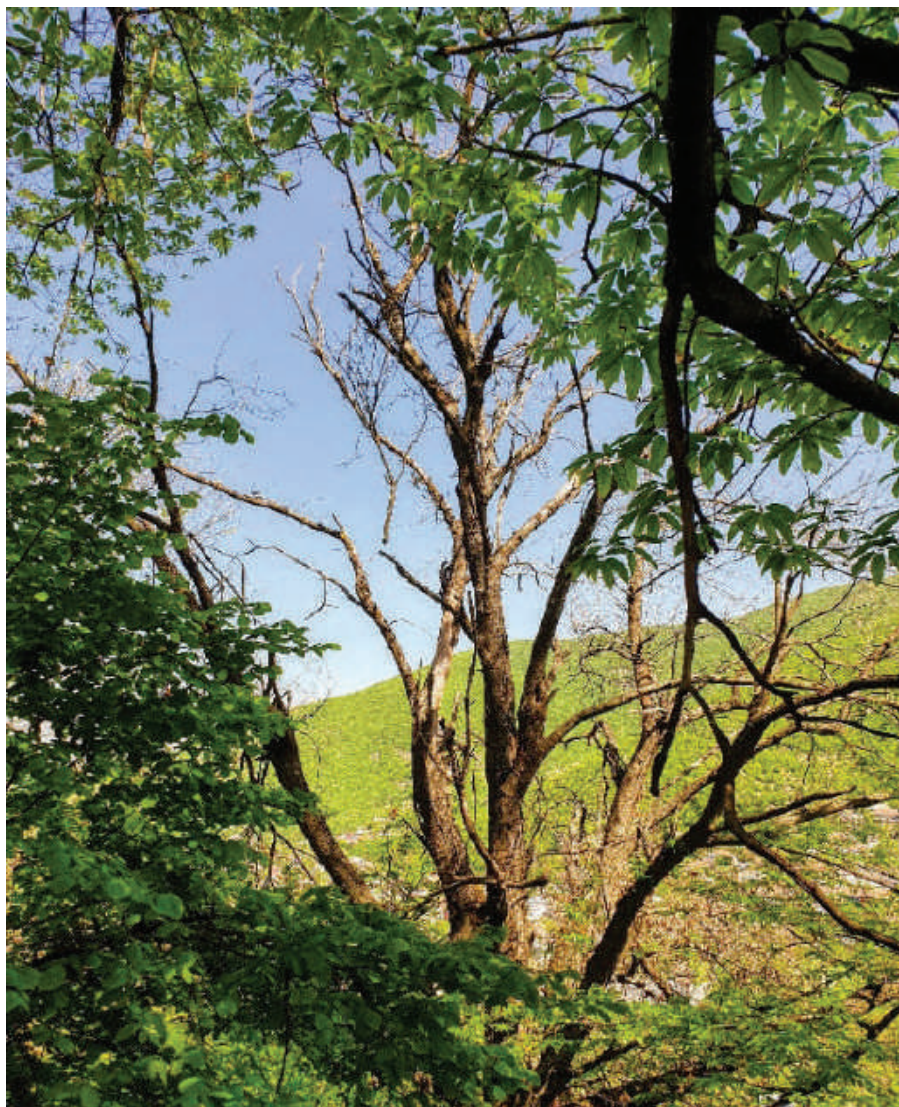
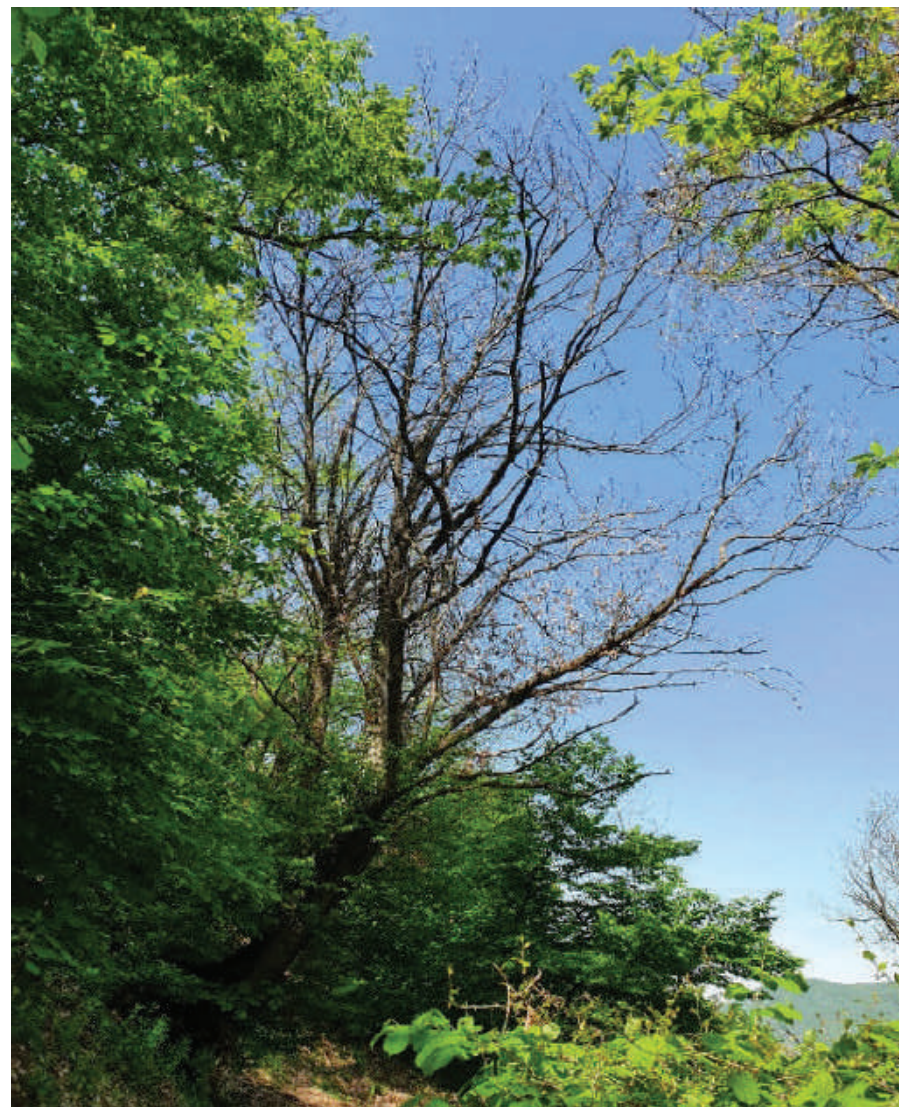
Figure 88. Dried chestnut trees

Although the garden is well preserved by the local forest department in recent years, the garden is not cared for. Currently, there is a gradual drying of chestnut trees in the area (Figure 88). According to forest experts, the chestnut trees have been affected by fungal diseases. At present, it is recommended to carry out agrotechnical measures against the disease by specialists, although there is no preventive measure that can be fully effective for this disease. These preventive measures include the use of mechanical methods, cleaning of dried and decayed parts by infection, cleaning and dilution of damaged and dried branches. At the same time, in order for the tree to regenerate itself, fungicides must be splashed, or injections of stems should be carried out. Specialists recommend that this process be carried out in the winter months.
