# **CONSERVATION MASTER PLAN** OF THE HISTORIC Center OF SHEKI

The State Tourism Agency of the Republic of Azerbaijan  
**2020**

**Historic Centre of Sheki  
with the Khan's Palace**  
inscribed on the World  
Heritage List in 2019

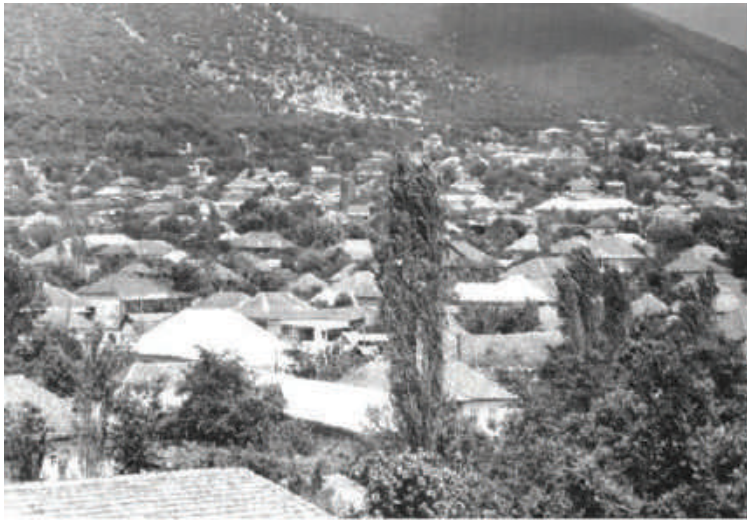
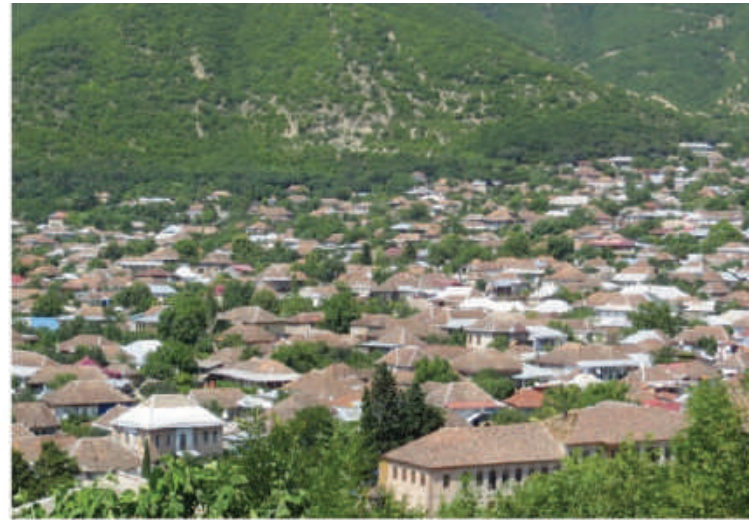
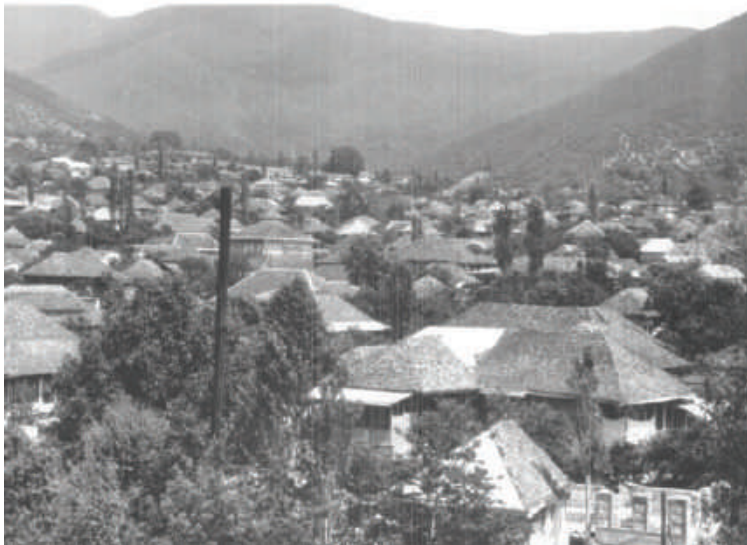
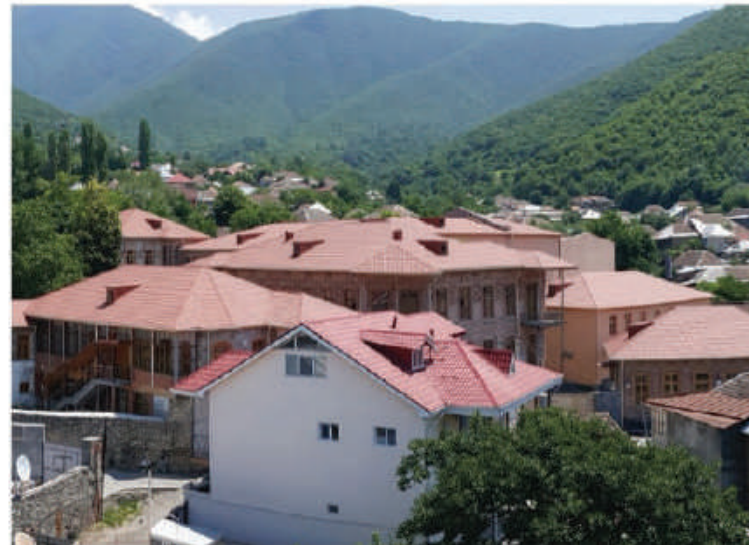
Figure 93: The layout of the village, with historical photo of XX century from a distant point of view, has been preserved on the first comparison (on top); but from a nearest point of view, in the second comparison (photos above), the scale and shape of the buildings has changed the traditional landscape.

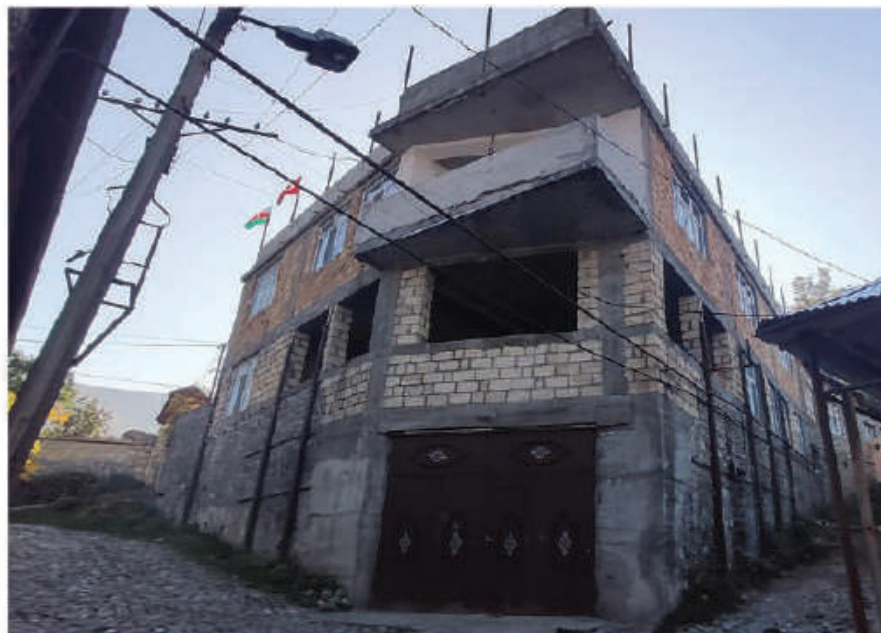
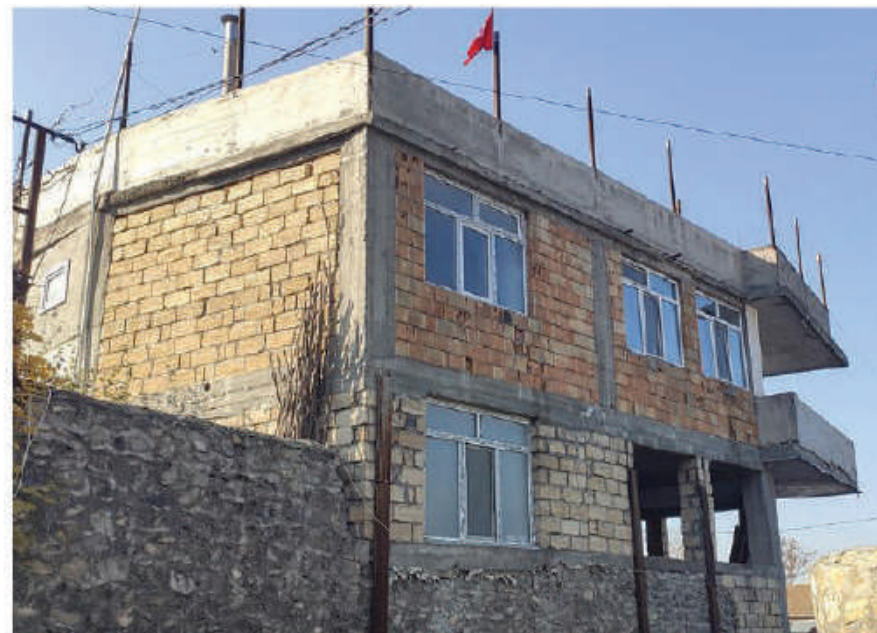
## 1. Haciseyidov Tofiq's House

**CHARACTER:** The building does not reflect the character of a traditional house in total. Because of size and scale, building tries to be dominant on the edge point. Traditional houses are humble and aesthetically naive and appreciate the environment. Here, the building is very sharp and cold in manner.

- *Surface of the building can be coated with yellowish composite plaster which has a certain resemblance of traditional coating, because of being bright color yellow coating may not work. It is better to analyze the surrounding and surface of the building respectfully its surrounding.*

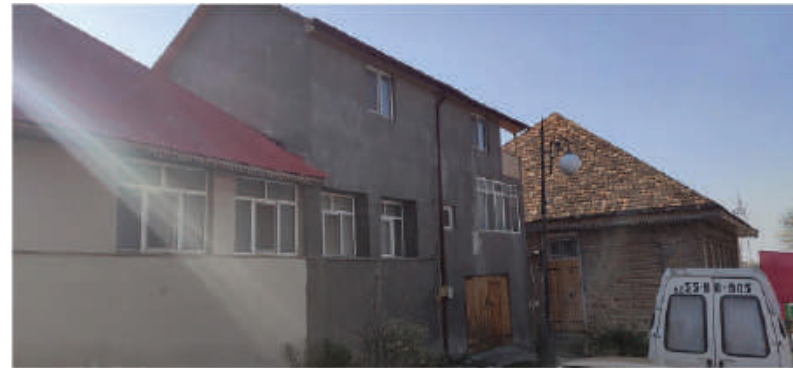
Otaq Eshiyi 1

**CHARACTER:** Otaq eshiyi 1 roughly has a similar character to those in a historical setting. Despite proportions and scale is neglected rest of the elements that compose the form create certain associates with traditional houses.

- *Otaq eshiyi 1. Covering the roof with terra cotta tiles, adjusting facade openings (windows) proportionally to traditional buildings, and coating the facade with appropriate material may help the building to adjust itself to its surrounding.*
- *Otaq eshiyi 2. Because of its form, any cosmetic touches to the building will not be adequate for adaptation. To demolish and rebuild it is the best option.*

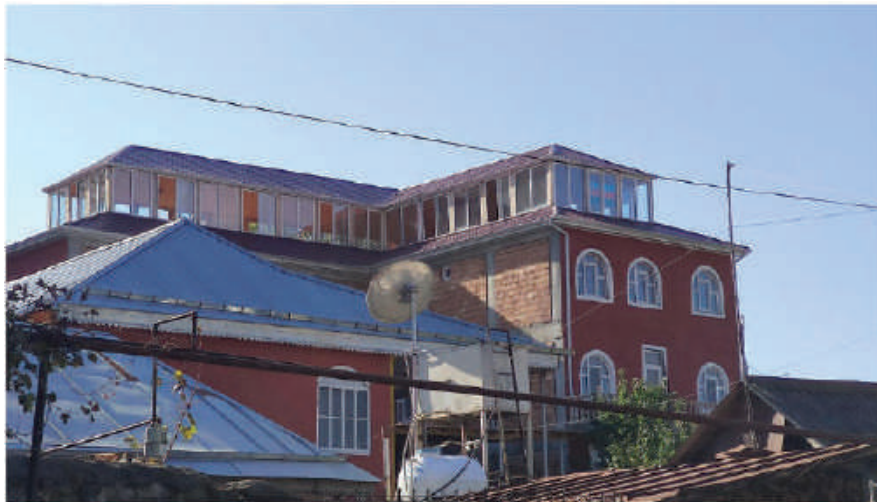
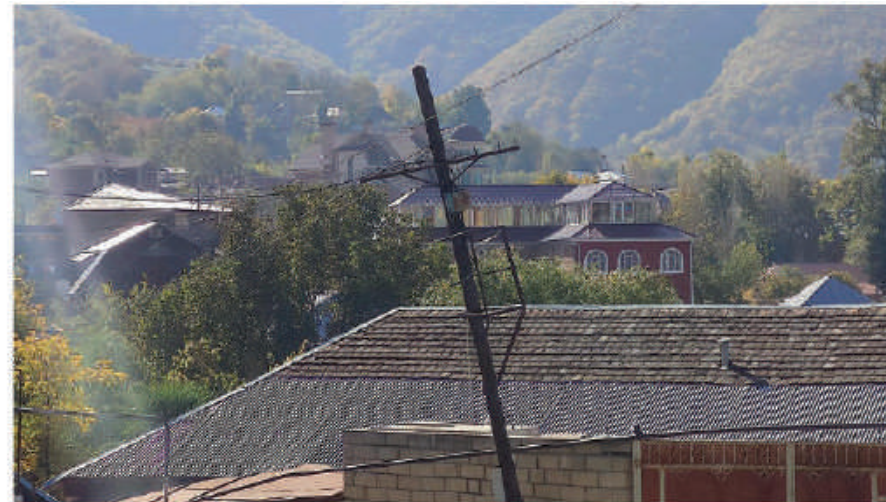
### 3. Old Nukha Hotel

**CHARACTER:** The building locates in between trees and can be seen from far away. Thus it has got the specialty of being a vista. Building in general distinguishes itself differently in material and elements. Consequently partially reflects and partially neglects the harmony of its surrounding.

**SCALE:** The scale of the is different and one level higher than its surrounding. But the vicinity where the building sits consists of mainly low profile one-story. This is the main reason why the buildings do not reflect the general harmony of its surrounding. Traditional houses around almost play a 'hide and seek' in nature. In this context new construction has to follow the 'game' of other buildings. Here the building exhibits itself and trying to be dominant.

*View space on top of the building to be replaced with lightweight structure. A new design is necessary (Colonade of arches can be a useful option)*

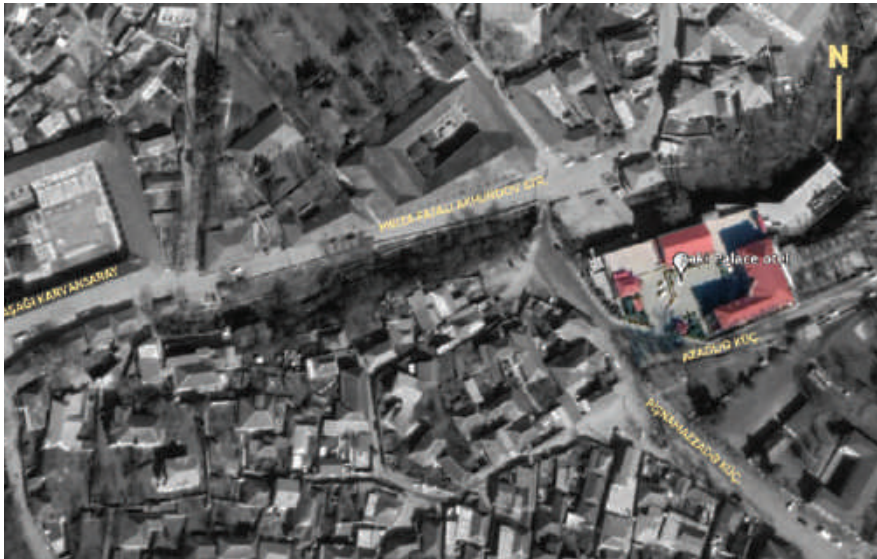
## 4. Sheki Palace Hotel

**CHARACTER:** The building is included in the category of residential, commercial buildings. Building exhibit itself as a monumental structure due to having strong symmetry, long window heights, sharp window slopes, anchoring two wings perpendicularly and connecting them in the vertical entrance block. The front part is designed for parking space. Having a large empty front which allows the building to be seen from a distance. Thus it creates a sense of authoritarianism in the area, which is very uncommon for historical settings.

**SCALE:** The scale of the building resembles “a building divided into small parts” and diffused on the landscape. The height of the building is not appropriately solved because of presenting itself from a distance and competes with the existing height profile.

- c. *Facade color to be changed that is similar to mud.*

*Laying a garden in the front yard will be helpful to cover the building partially, at the same time reinforce the gardening idea.*

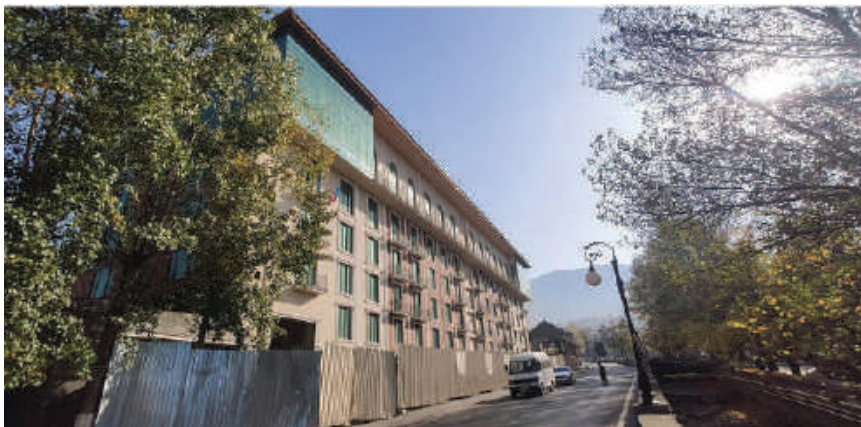
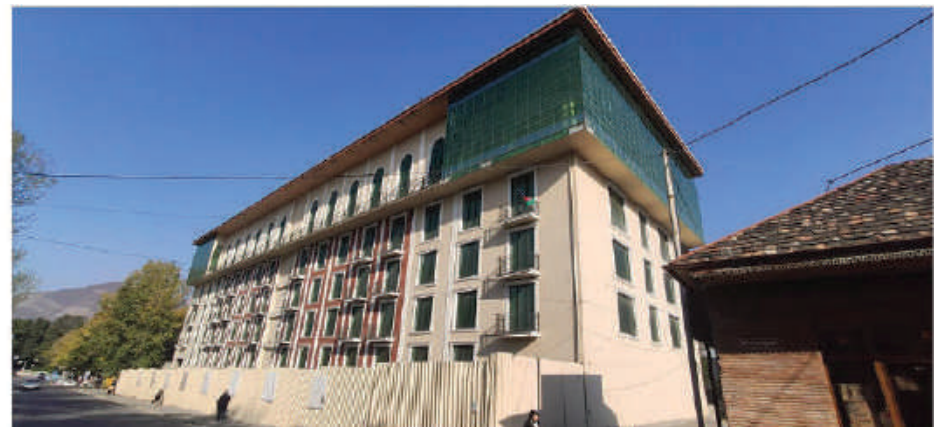
## 5. Building of Dormitory

**CHARACTER:** Building was designed neat and symmetrical and exhibit itself as a landmark. Materials and elements partially compatible and partially distinguishable.

**SCALE:** Because of being higher than the houses next to it, the building cannot be considered as successfully scaled. The scale of the building is the main problem with its dominance.

- *The last story should be removed in order to maintain the height profile.*
- *Window frames and window glasses to be changed or adapted*

- *white cornices and white window second frames to be removed or if ornamentation is necessary decorative elements like 'shilasar' can be considered for cornices.*
- *The roof of the building to be changed with appropriate material.*
- *Infrastructure elements on the facade to be hidden.*
- *Because of being a long building, surface material to be selected pale or a material which will blend the whole building in its surrounding.*

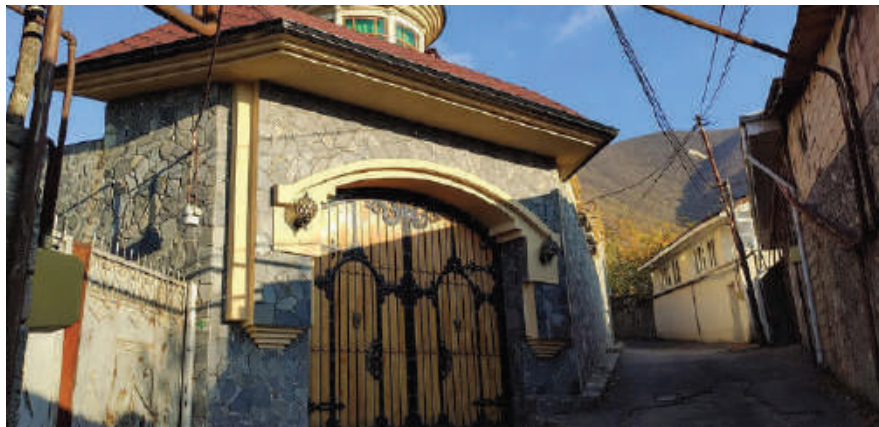
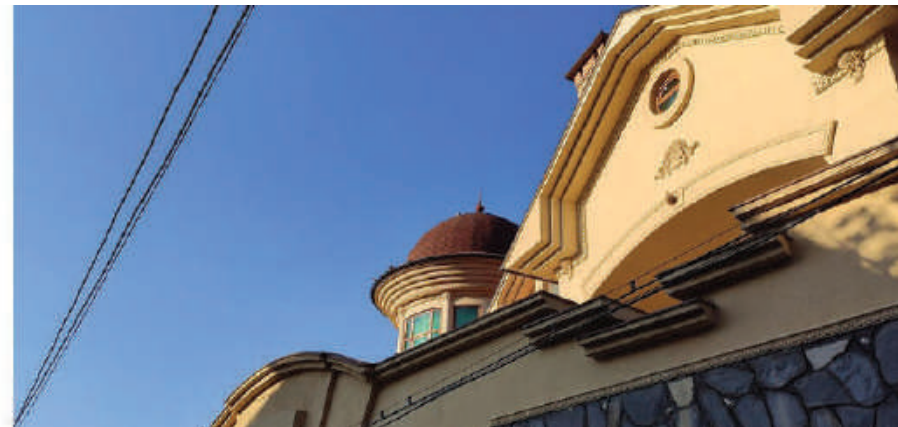
**CHARACTER:** The building is a severe case of incompatible buildings because of its many-sided gabled roofs and form selection. The building has a character of a massive block which cannot 'breathe'.

**SCALE:** The building is resolved spatially with heavy masses. The building is reasonably higher than its surrounding homes which are generally one and two-story low-profile buildings.

- *If possible, to demolish and redesign and rebuild the project.*
- *If demolishing it not possible, then the possible actions to be taken as below:*
  - a. *Replace facade color with paler or with a color that will be appropriate with its surrounding.*
  - b. *Replace pinky bricks*
  - c. *Replace roofing with terracotta or imitative material*
  - d. *Replace green windows. If green windows are against UV rays, then another solution needs to be found.*
  - e. *Traditional Sheki ornamentation elements like shebeke and shileser can be paraphrased and used for cornices and balcony handrail.*
  - f. *Entrance need to be diminished in its 'fancy' look, should be modest.*

*Snakeskin fence wall surface should be changed and adapt to the ones it's surrounding.*

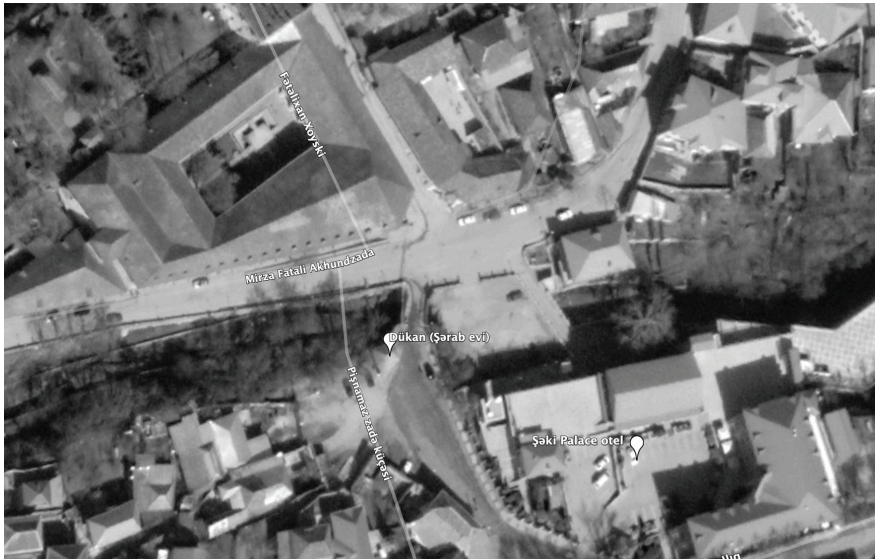
## 8. Wine shop (Dükan Şərab Evi)

**SITING:** The building locates on the opposite of Upper Caravanserai and has got open yard on the back and a tree in front of it. The building locates on top of the bridge, which is a recommended site for a building. The siting of the building is successful because of having small stairs in the front and respecting the existing tree. The issue with the building is the location. Because of sitting almost on top of the bridge.

- Replace colored red bricks on the surface with natural red brick.
- Redesign or relocate the building.

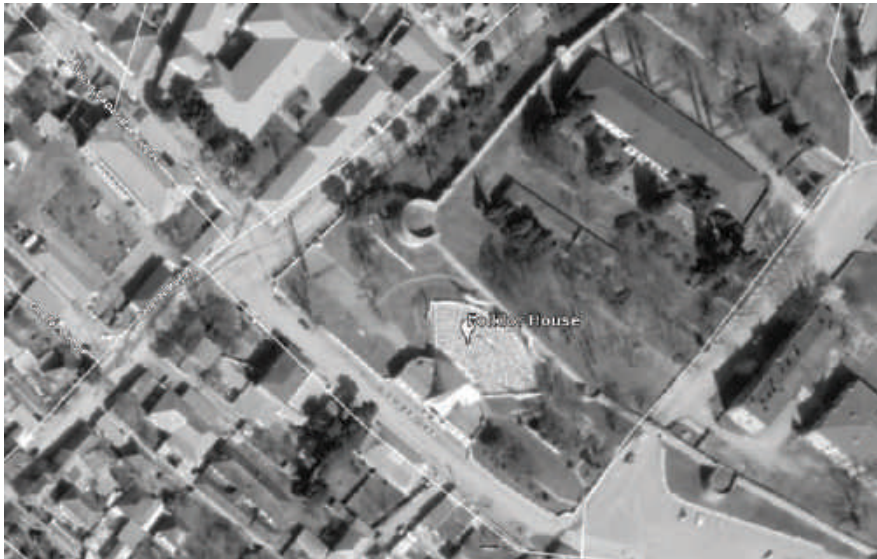
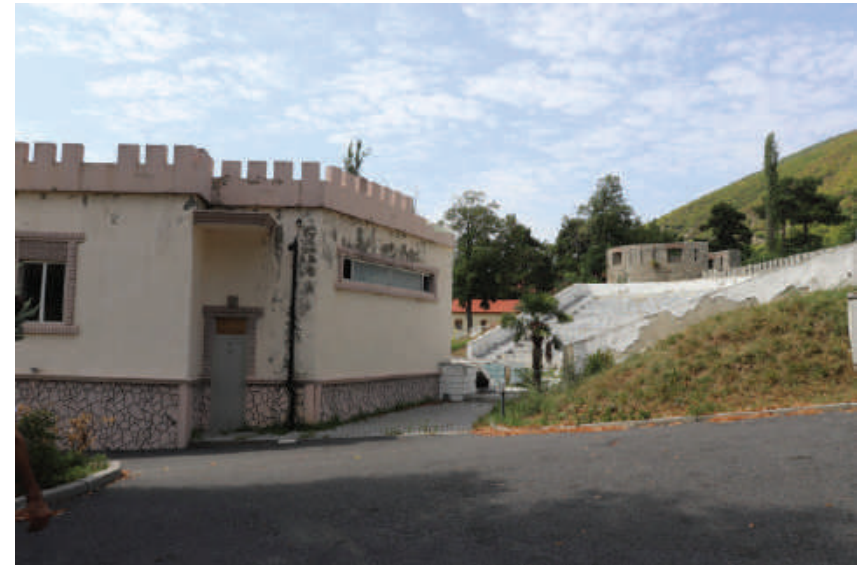
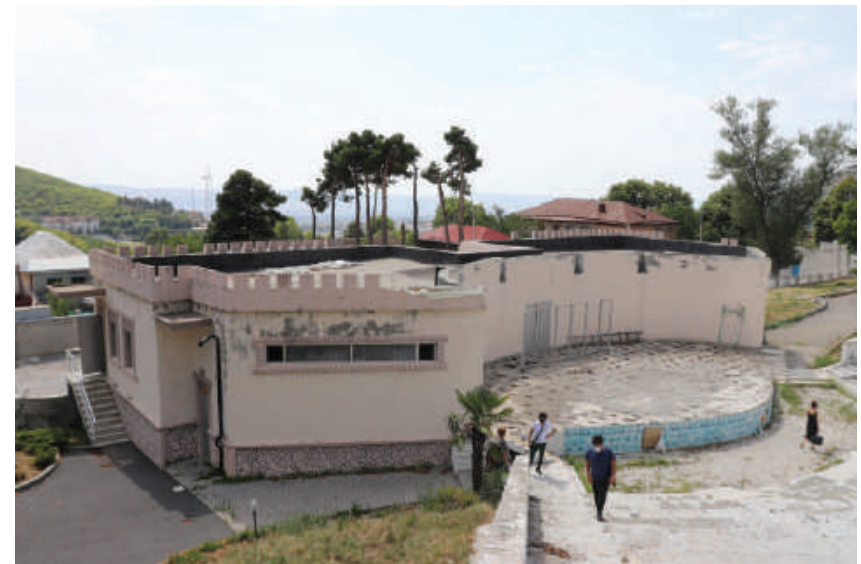
## 14. Folklor House

CHARACTER: The building is a typical open-air theater on the slope, and it is in the process of abandonment and decay.

SCALE: Despite the building partially hides the facade of Sheki Fortress, the scale is designed appropriately. The building does not over trample the land both horizontally and vertically.

- *The condition of the building is abandoned, it is probably because the building did not meet the standards of service or the necessity of having a folklore house in the area became less important. In both cases, if the structure is not demanded anymore, actions below can be applied sequentially:*

- Rehabilitation period to be decided*
- During a process of rehabilitation a new adaptation design and a program to be prepared. A new design should consider keeping the form as it is and giving it more blendable appearance to hide the amphitheater on the green slope.*
- Top part (one or two rows) of the building to be removed in order to create an adequate visibility for the fortress wall behind it.*
- Technical room and the stage to be removed and a new lightweight, modular, easy constructible structure to be erected.*
- Wood and lightweight metal elements can be used for any new structures.*

*A new design and a program will help to lessen demolishing works, and adapt the building to its environment and at the time will create a new recreation space for people.*

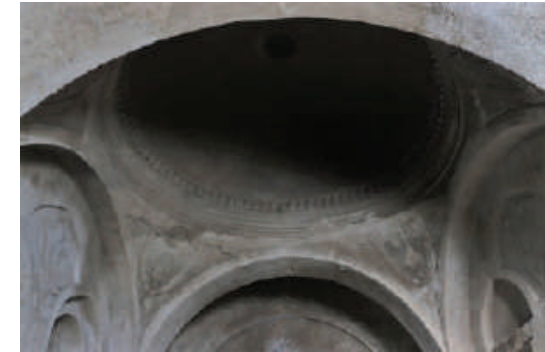
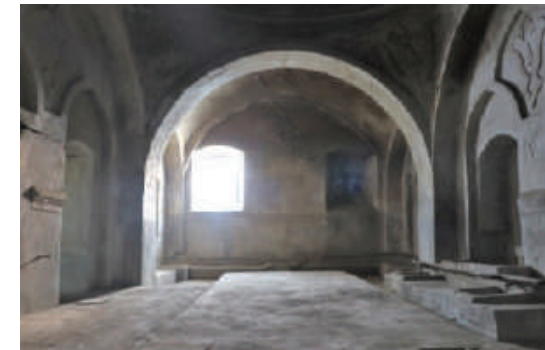
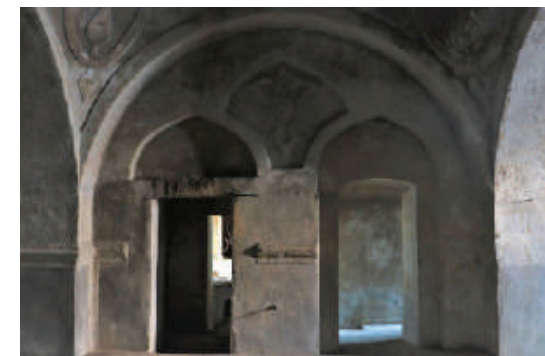
Figure 101. Appearance of inner hall.

The main hall and auxiliary rooms around it are called "indoor" and are intended for hammaming, the area of which is 60 m<sup>2</sup> (6 m x 10 m). These two groups of rooms combined with a system of auxiliary rooms. There are 7 small pools for washing in the inner hall. There is an entrance from the main hall to the secret place section. This secluded place itself is divided into 3 cabins with small arches.

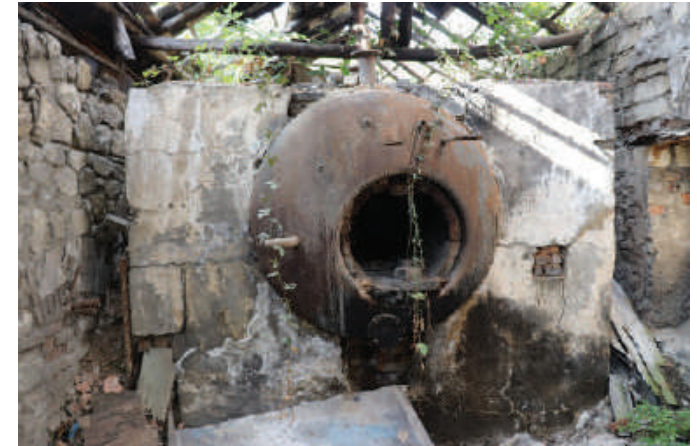
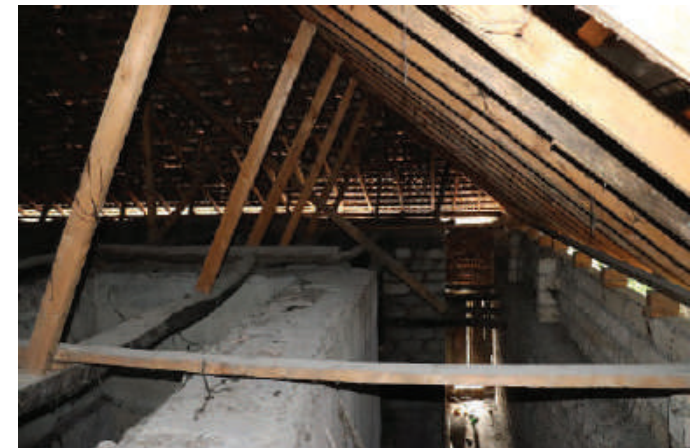
Figure 105. Present view of the boiler-room.  
b. Garret, water ponds and technical entrance

The building is in satisfactory condition. Currently not in use.

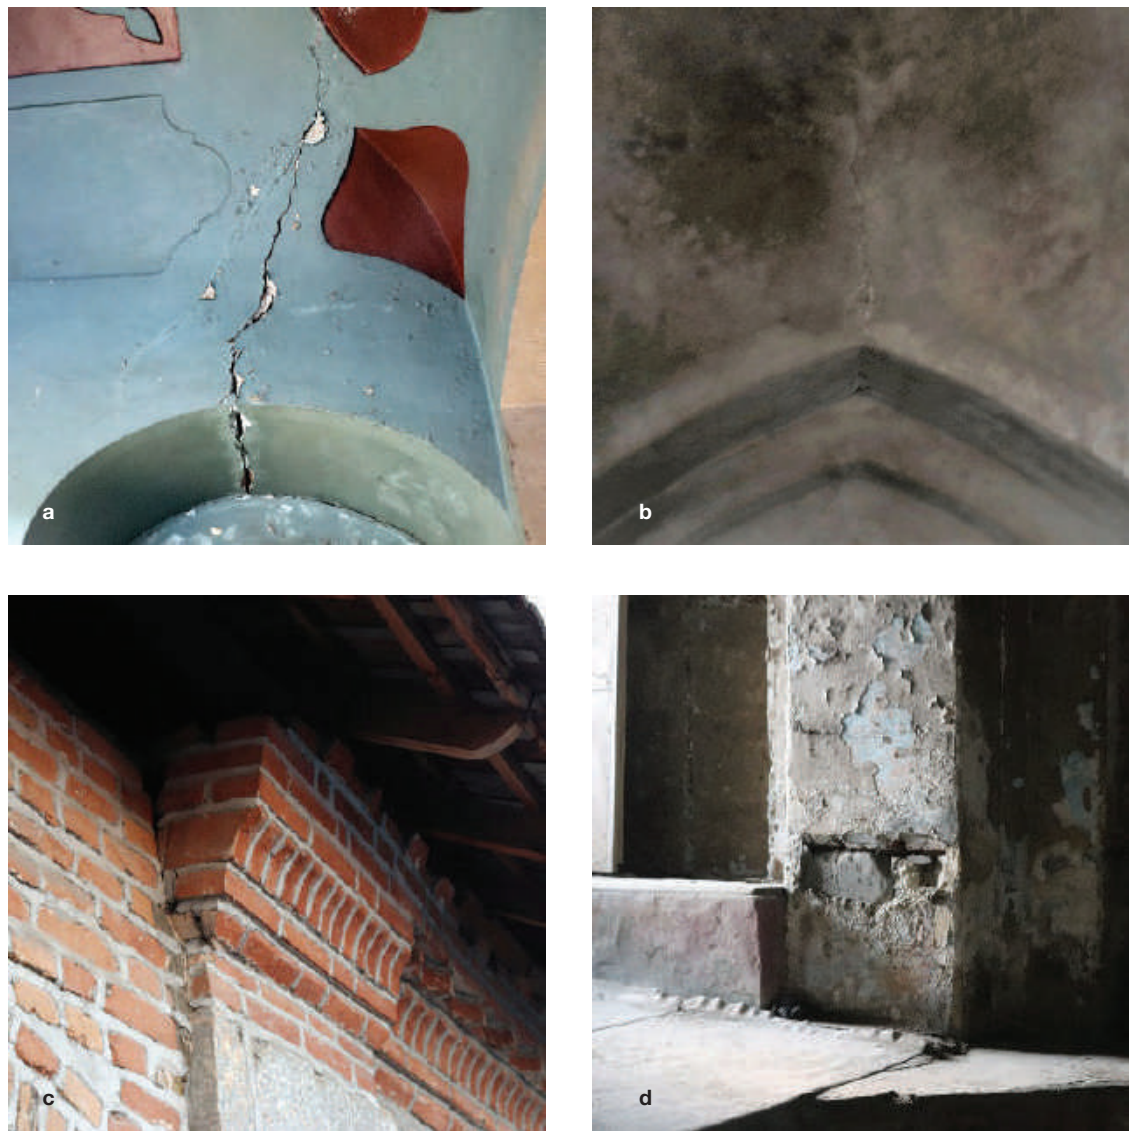
Figure 106. Main visible cracks and damaged parts (from left to right) a. at the arch of the entrance corridor, b. - the arch of “inner” room with a water pool, c. - the cornice at the top of the annex of the technical entrance, d. - Pillar in the outdoor room.

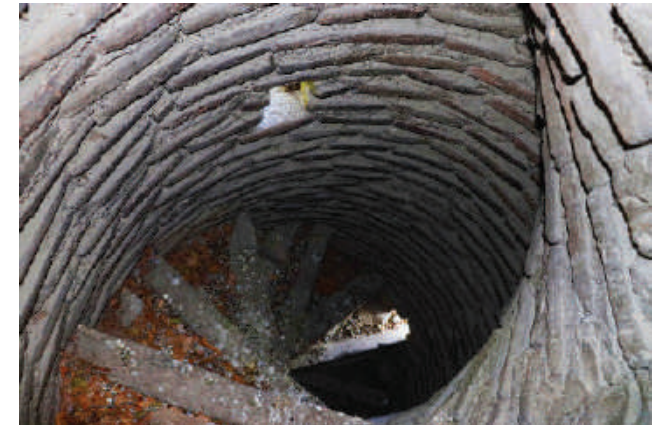
Figure 113. Interior banisters of the minaret

The height of the minaret is 19,39 m, the diameter of the circumference of the plan cross-section is 2.48 meters in the form of a cylinder. Minaret the interior of the building is a staircase built of baked bricks and wooden stairs. The thickness of the wall is 39 centimeters. On the surface of the wall, there are niches with 20 cm width for lighting. Sharafa part goes beyond 22 cm on the surface of the minaret. In the lower part of the minaret's body surface, there are two-layered patterns in the form of rhombus. Minaret's porch has a roof in the form of a tent covered with metal plates over supported by 8 wooden bearings. Sharafa's hand-rails were later replaced and installed from metal. The height of its trunk to the top of the cornice is 13,94 m, and the height of sharafa is 3,17 meters.

Erosion is observed in the ready-made brick masonry in some places of Minaret. Therefore, it is also necessary to carry out cleaning and fastening work in the brick masonry of Minaret.

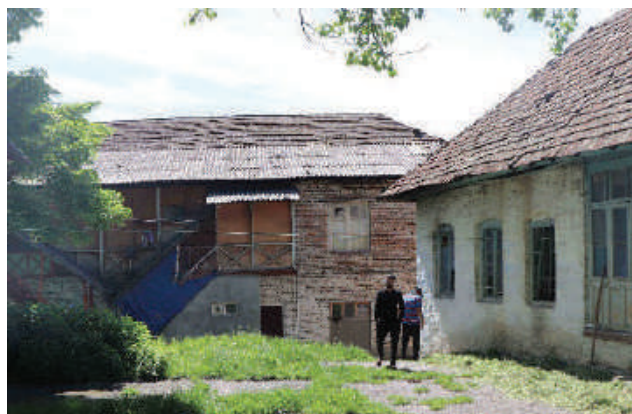
Figure119. On the left is the former Young Workers House, on the right is the abandoned building of kindergarten # 2.

The front facade of the building should be dismantled, as the reinforcements violate the visual image and are incompatible with the previous form. The building can be restored and turned into a library / museum-type cultural center serving cultural tourism and community.

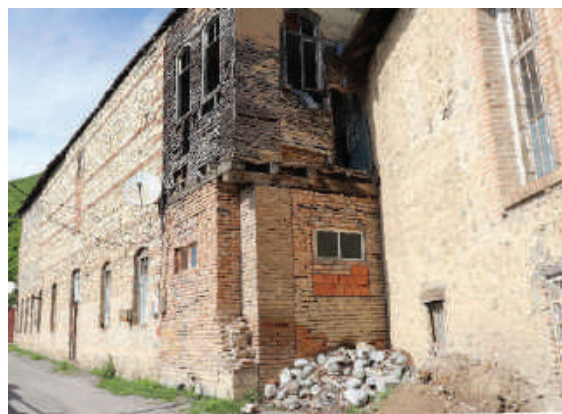
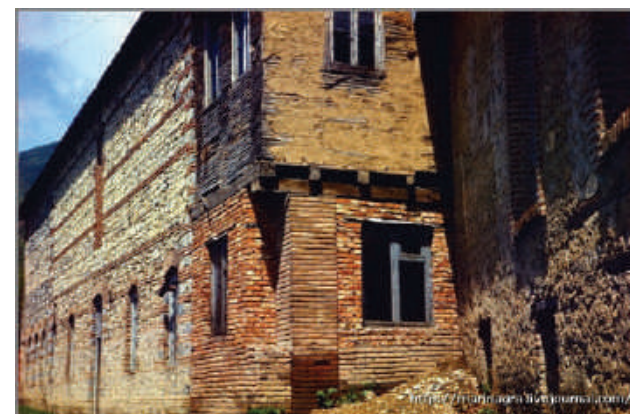
Figure 120. The old (1979) and the new appearance of the Young Workers House.

The former **Young Workers House**, partially adjacent to the eastern facade of the Khan Mosque, and now in a unsafe condition, was built in 1928. Seven families (Karabakh IDPs) were used to live in the buildings at present. In order to protect of the mosque, the families have been recently moved from the buildings to the new houses by the assistance of the state.
